Pump Room  
Tooting Bec Lido  
London SW16 1RU  
Historic Building Record

April 2019

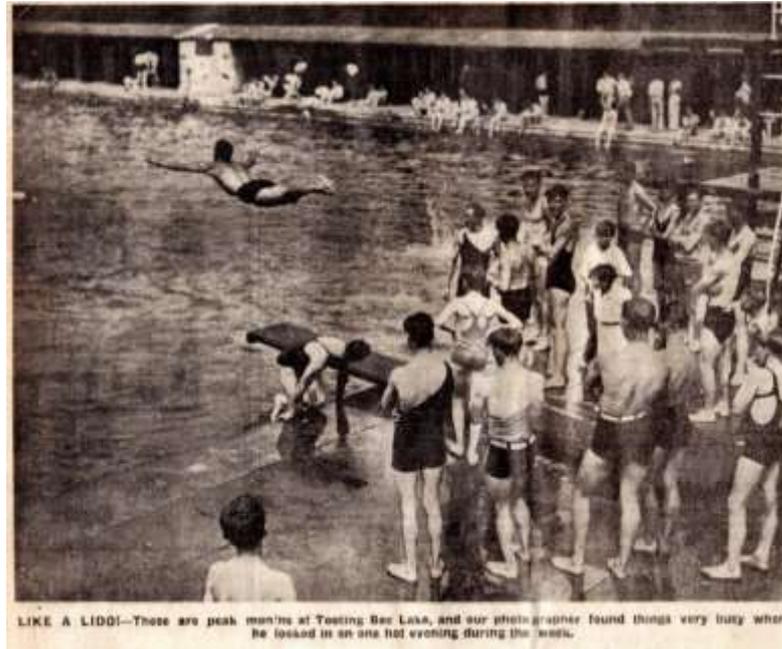
LIKE A LIDO!—These are peak moments at Tooting Bec Lido, and our photographer found things very busy when he looked in on one hot evening during the week.

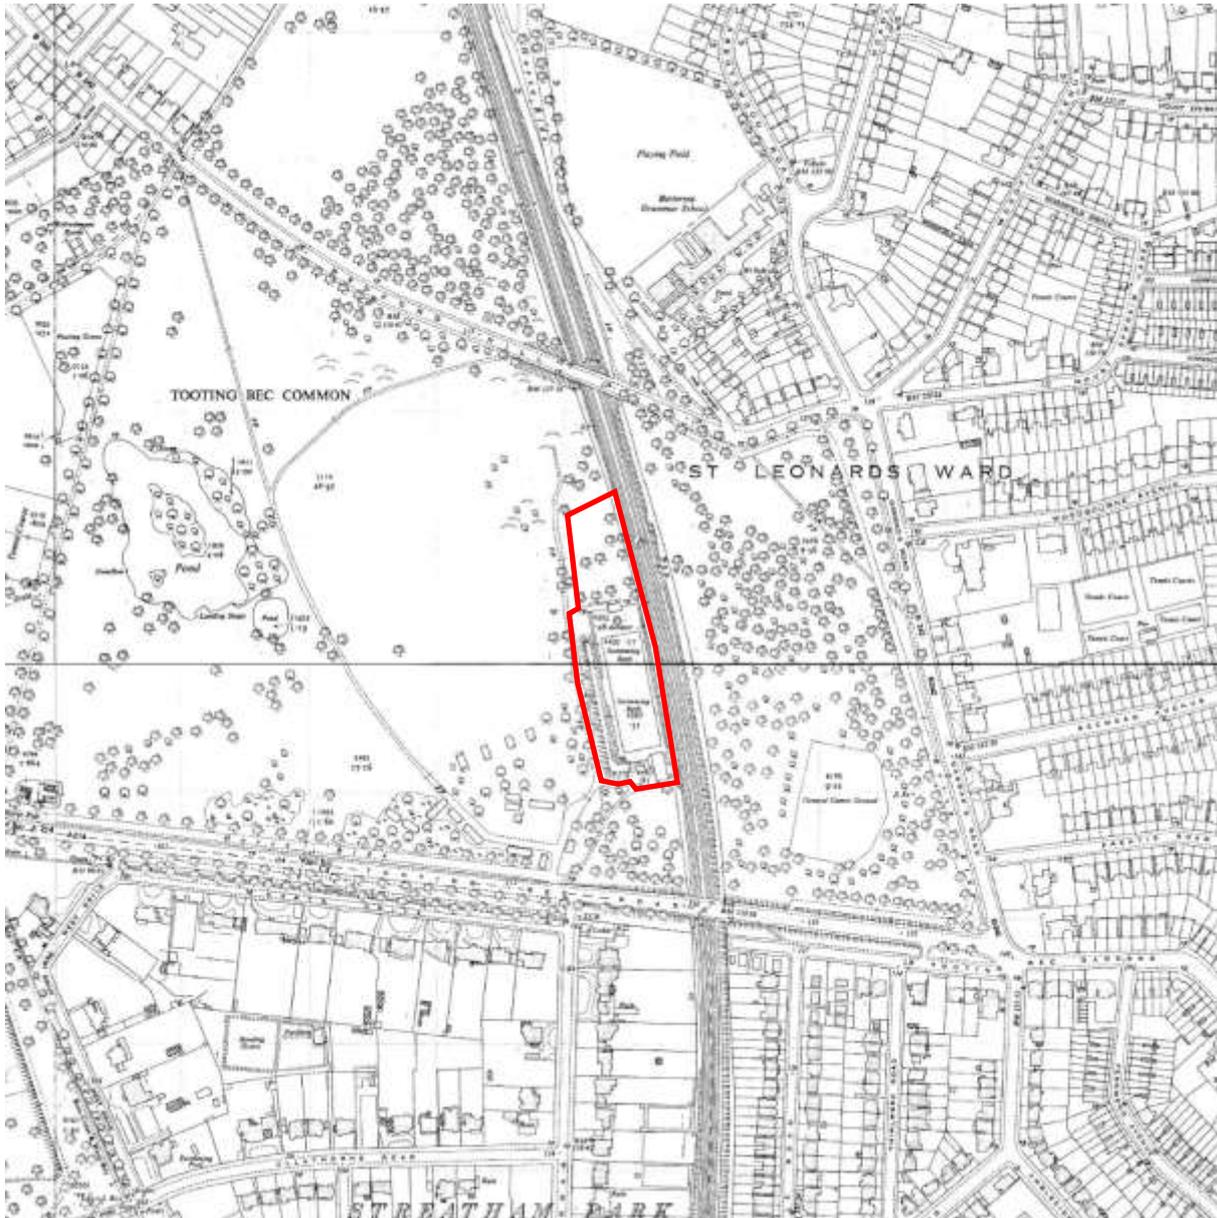
**Figure 5.18:** 1950-51 OS map with the approximate location of the Site marked in red. We can see to the northern side of the Site the new café and fountain have been built by this time. We can also see the large Pump Room to the south-east which replaced the previous building in the south-eastern corner. Note the two buildings were not on exactly the same plot, with the later Pump Room being marginally further east and also set further to the north and south. The initial 1931 Pump Room, was not therefore an extension of the previous building shown as extant on the 1916 OS map (see Figure 5.9).

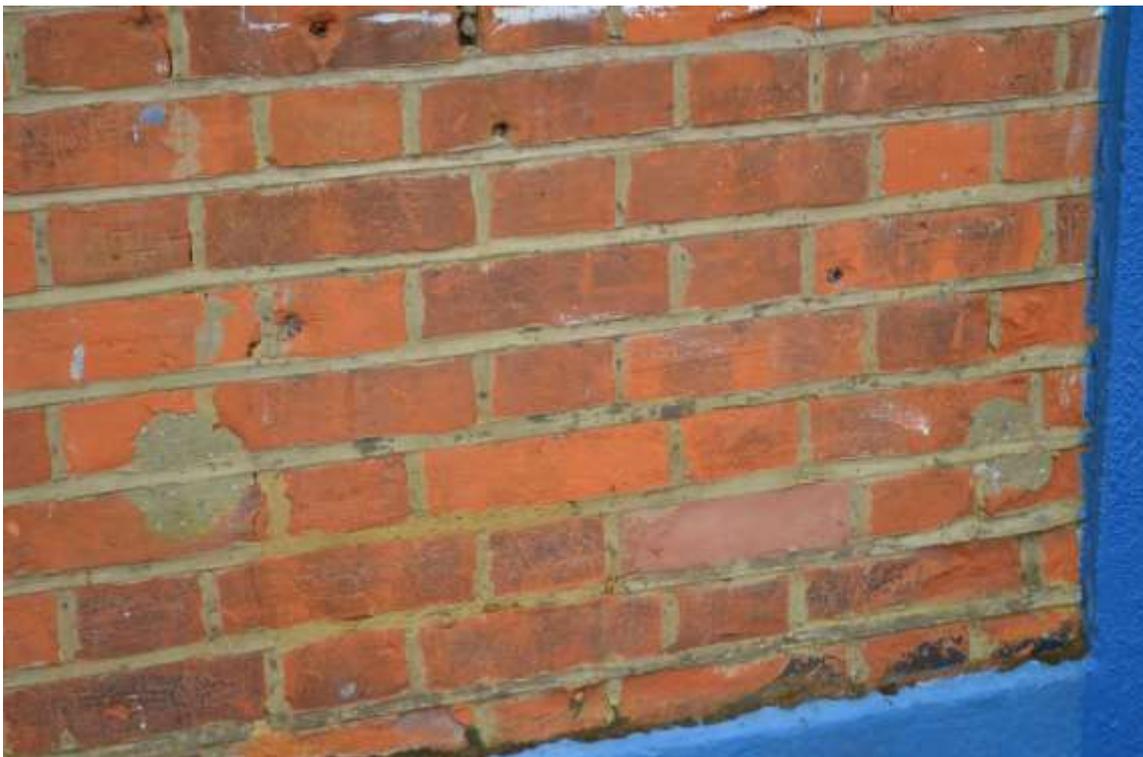
4: Section of poor quality pointing to the left hand side of the main entrance, above plinth render. Also showing mortar repair to one brick.

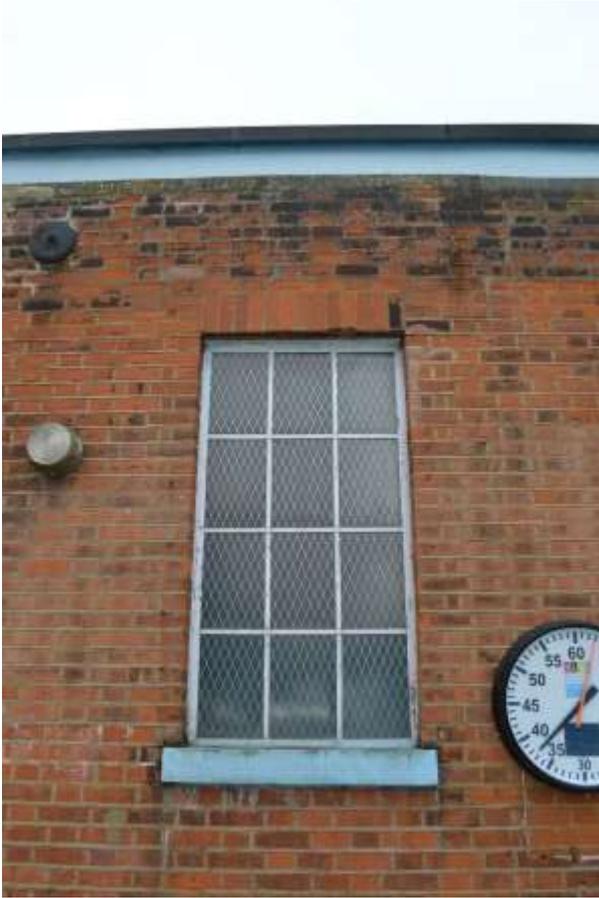
5: Eastern window on Northern elevation. Original to building.

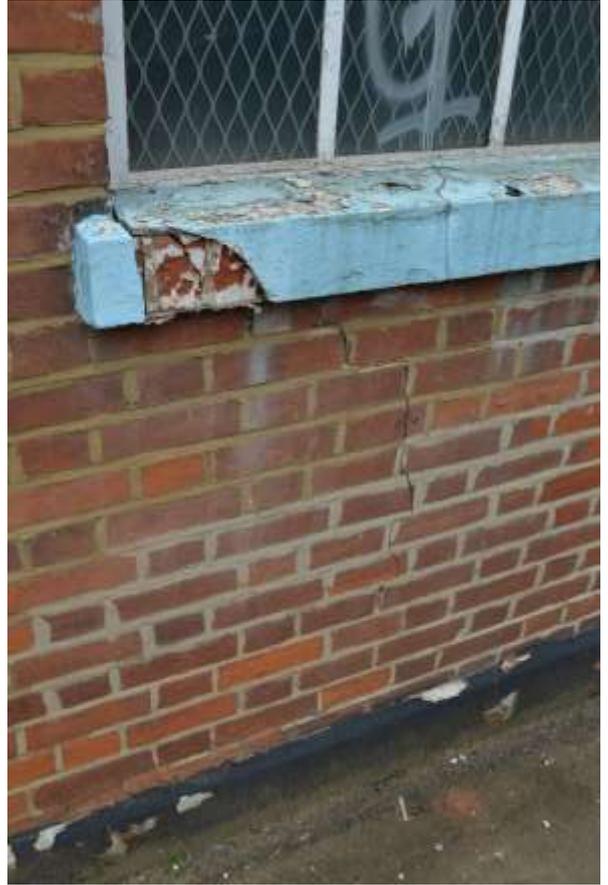
32: Lintel to most northern window on eastern elevation. Note crack to lintel and brickwork beneath.

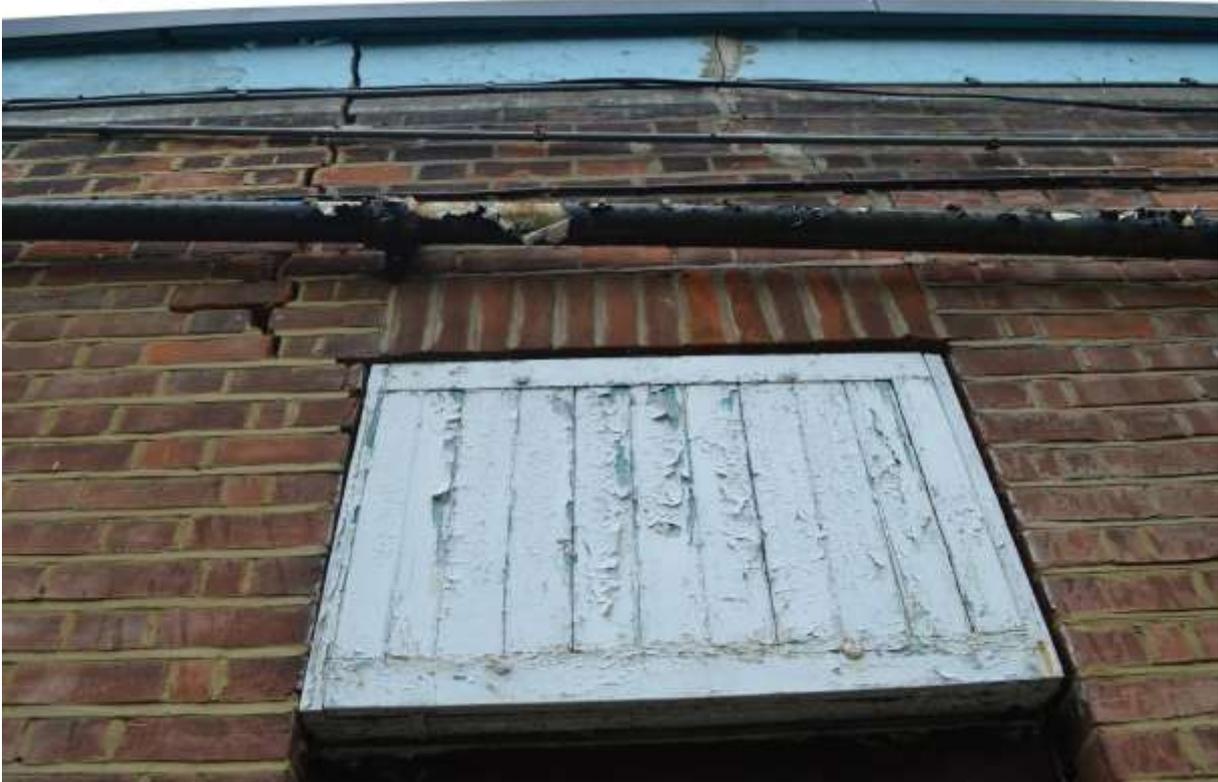
33: Upper part of central window to eastern elevation. Note the substantial crack to the upper left hand side.

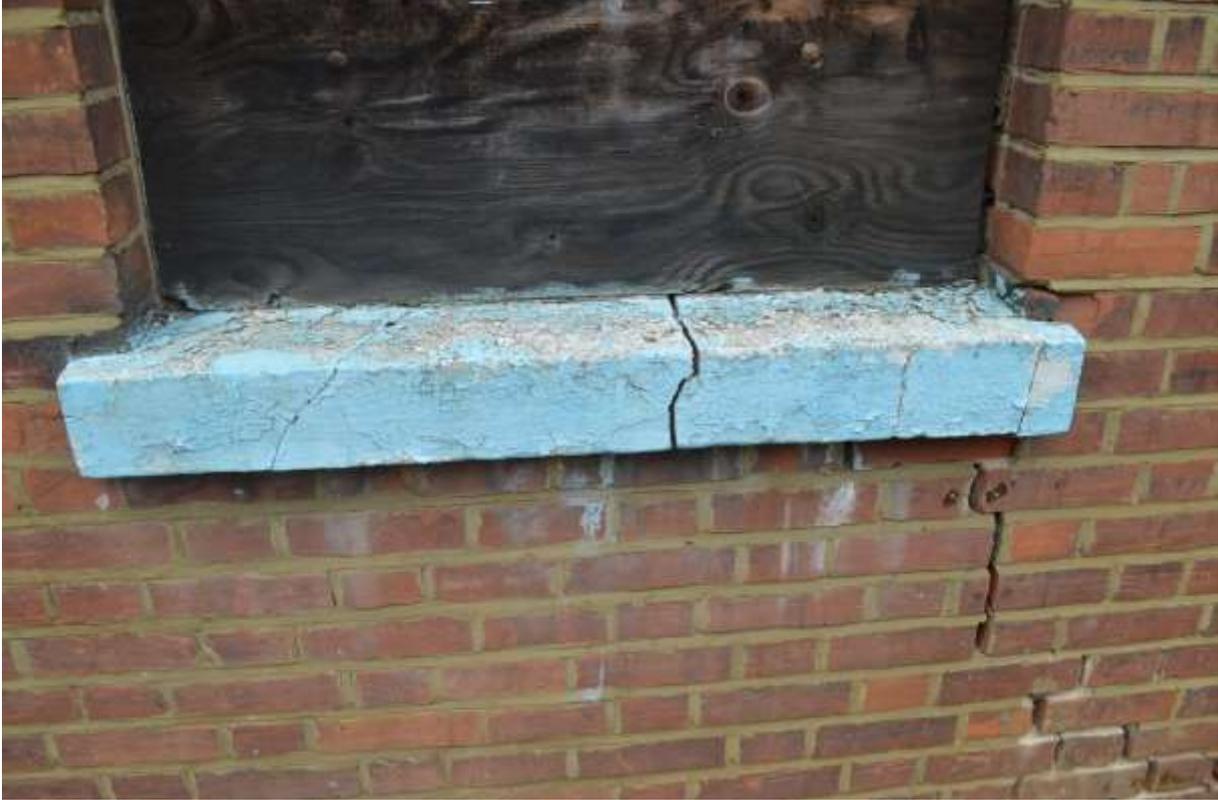
34: Lower part of central window to eastern elevation. Note the substantial crack to the lower right hand side.

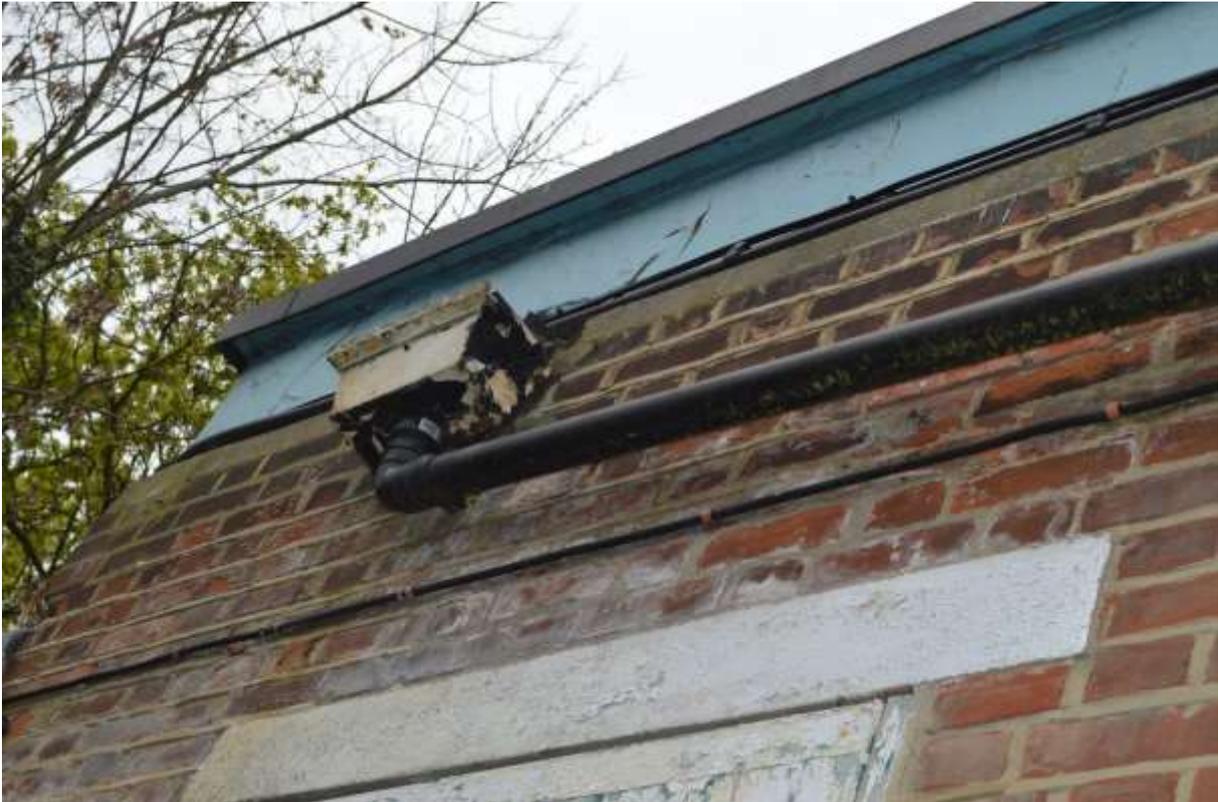
35: Cast iron hopper to the southern extreme of the eastern elevation.

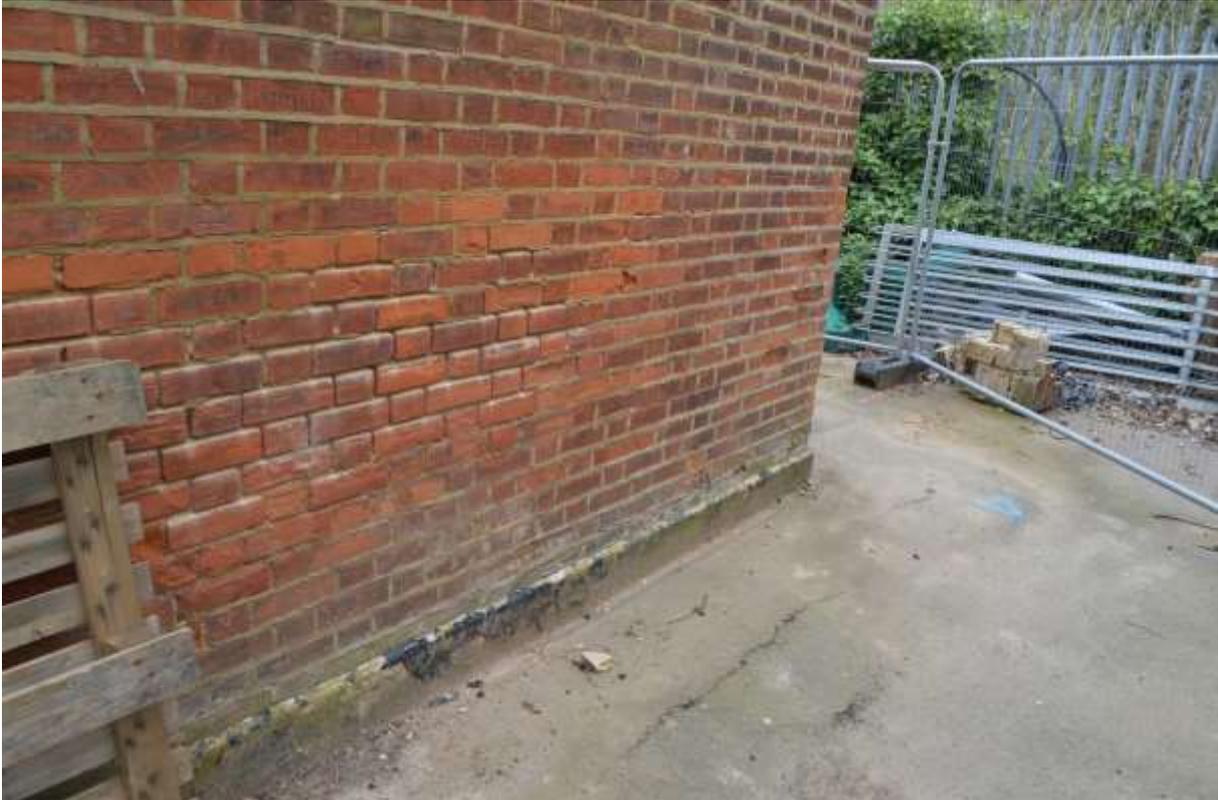
44: Pointing degradation on part of the southern elevation and brickwork spalling.

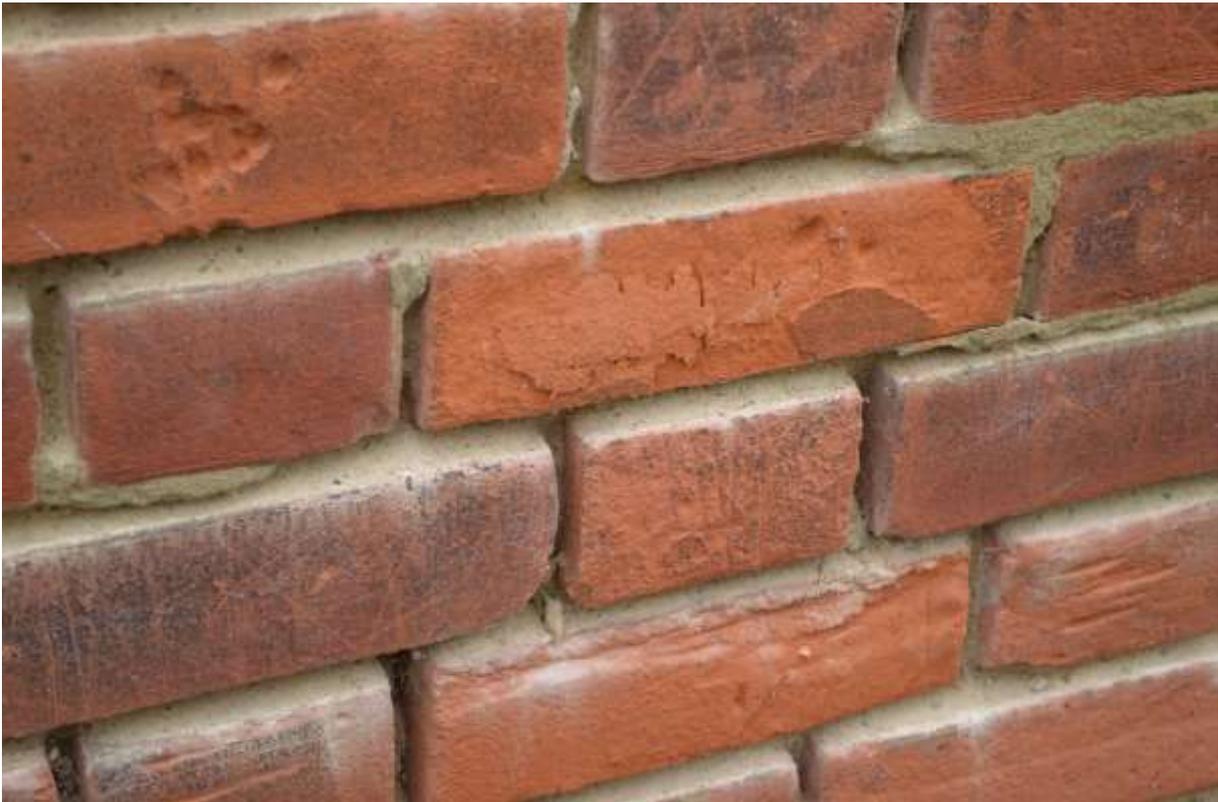
45: Pointing degradation on part of the southern elevation and brickwork spalling.

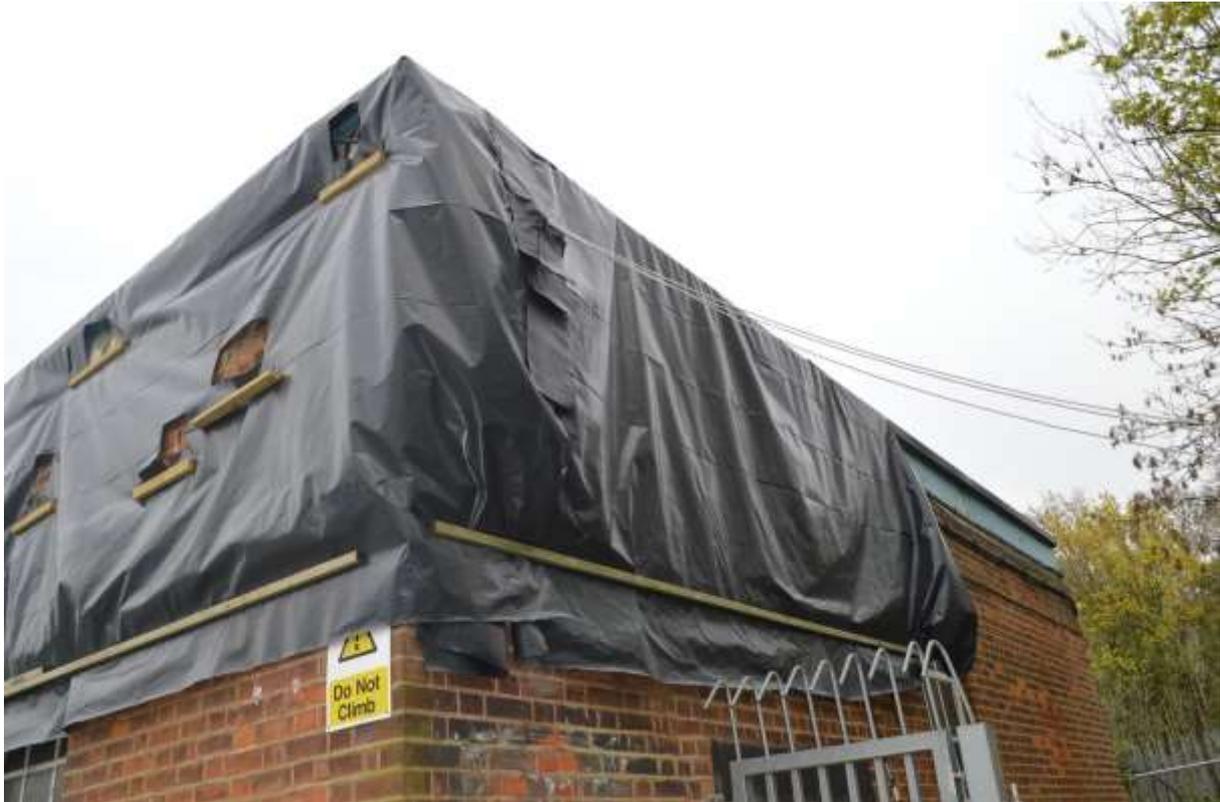
46: View of the south-western corner of the Southern Building. Note the temporary tarpaulin to the upper sections and temporary timber battens.

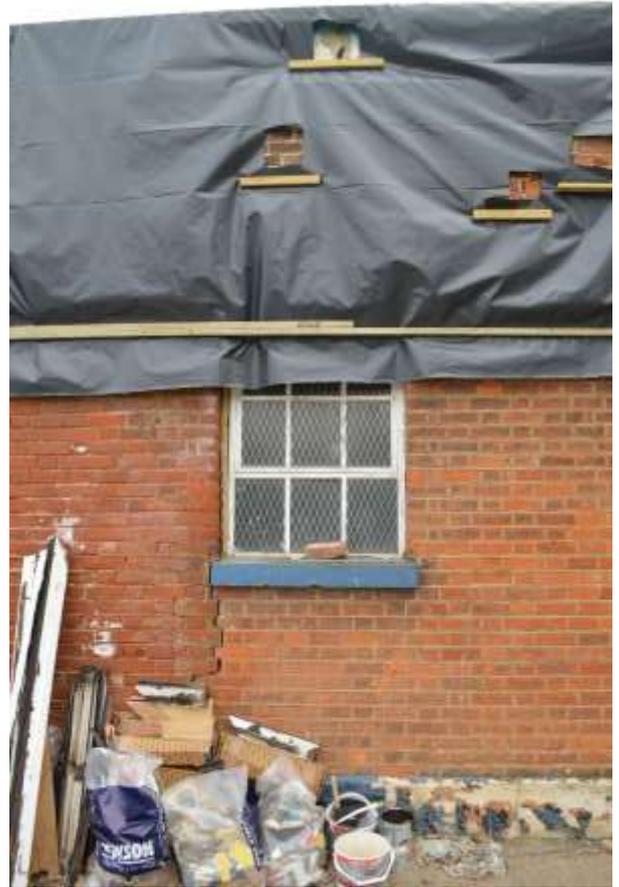
48: Note the numerous large structural cracks that have been left uncovered so that they can be monitored. Note the significant crack to the lower left side of the window cill.

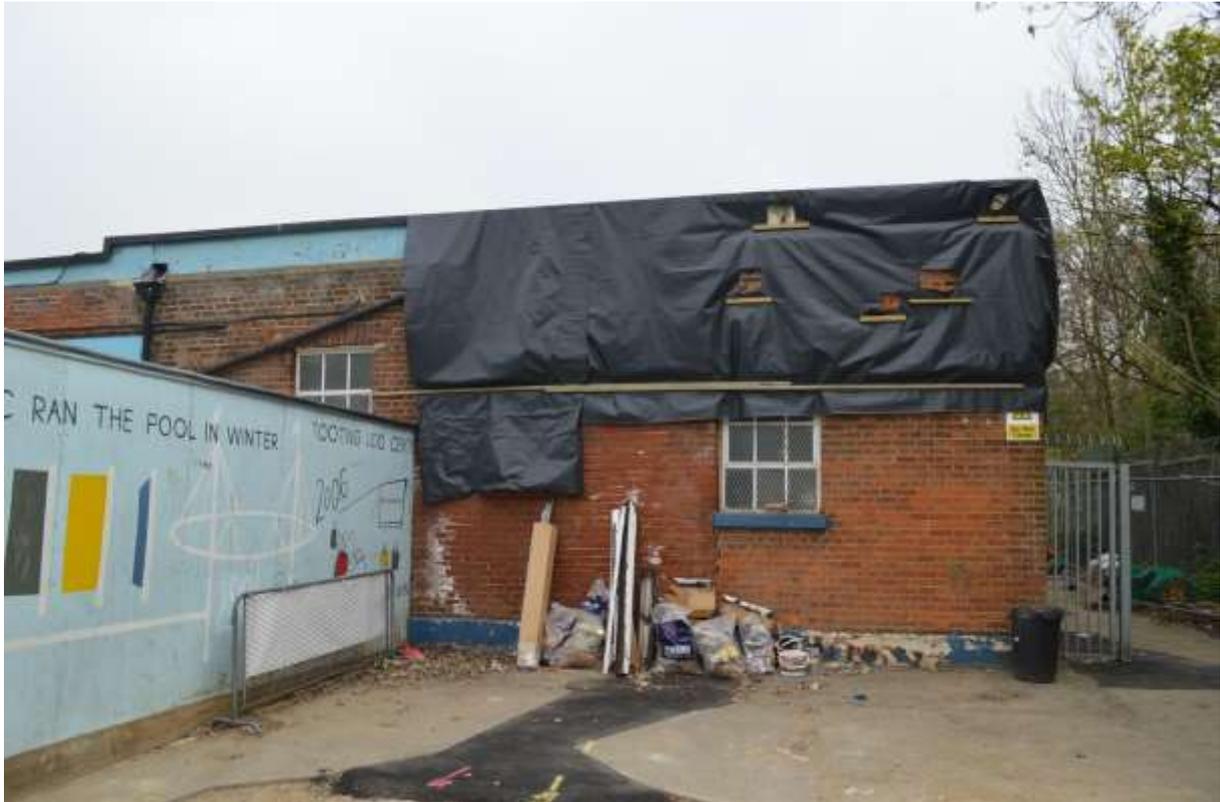
49. Western elevation of the Southern Building. Note part is obscured by hoardings.
