## Structural Assessment Report

REF: 25-123-251127-01RP

Coyle Kennedy Consulting Engineers was appointed to undertake a survey of the existing bungalow within the Mount Clare House complex. This report has been prepared to assess the current condition of the structure and to evaluate its suitability and structural adequacy for retention.

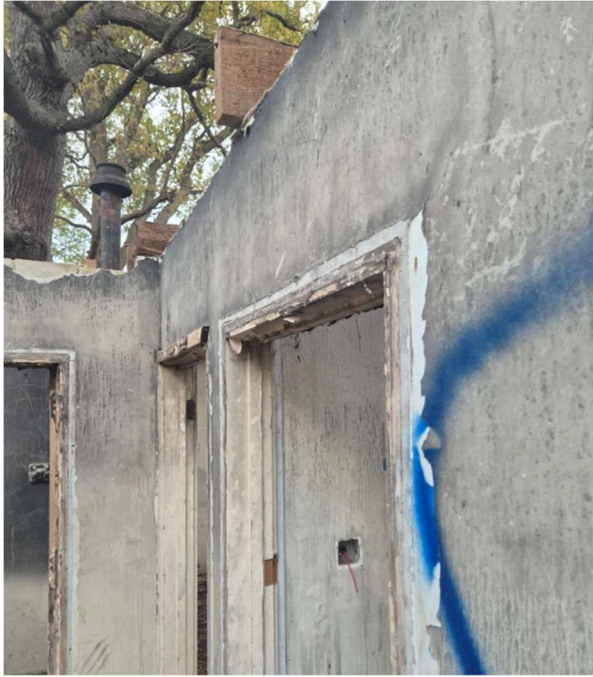
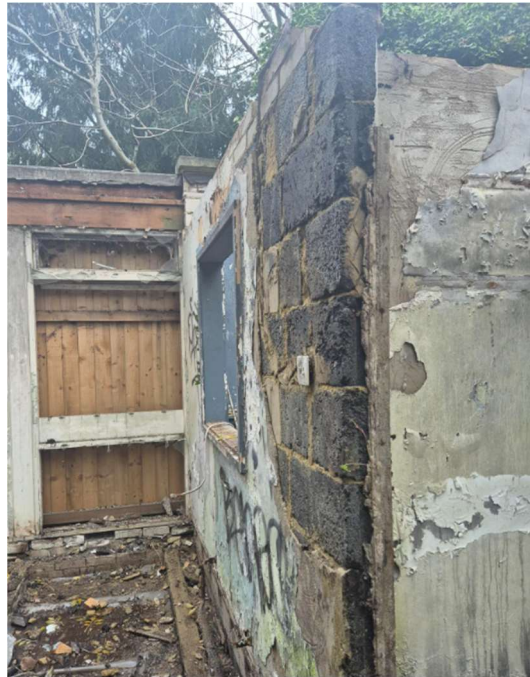
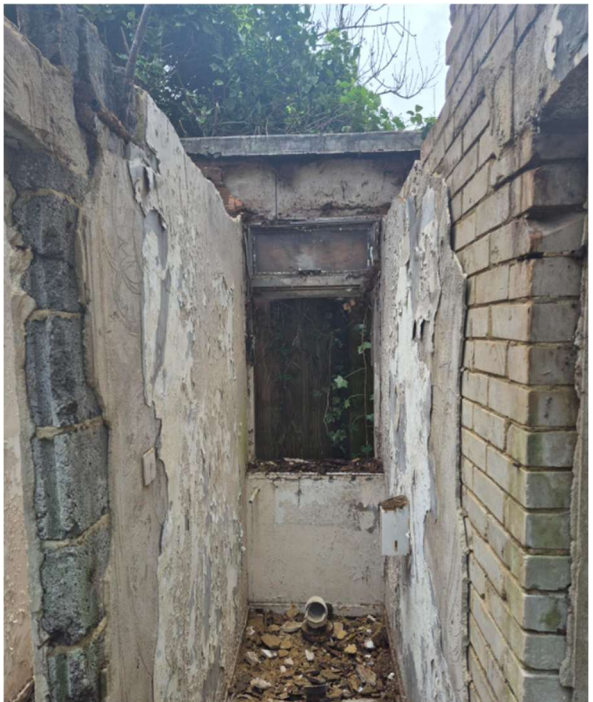
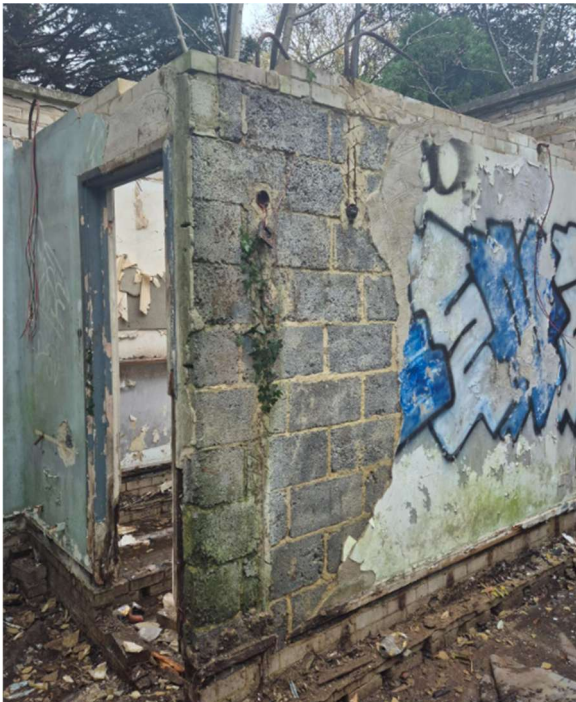
### **vii. Internal Load Bearing Walls**

All internal walls on site are a mixture of blockwork and brick. There is a small section of wall which was the old boiler room that is constructed in brick. This is possibly due to the room only having access externally.

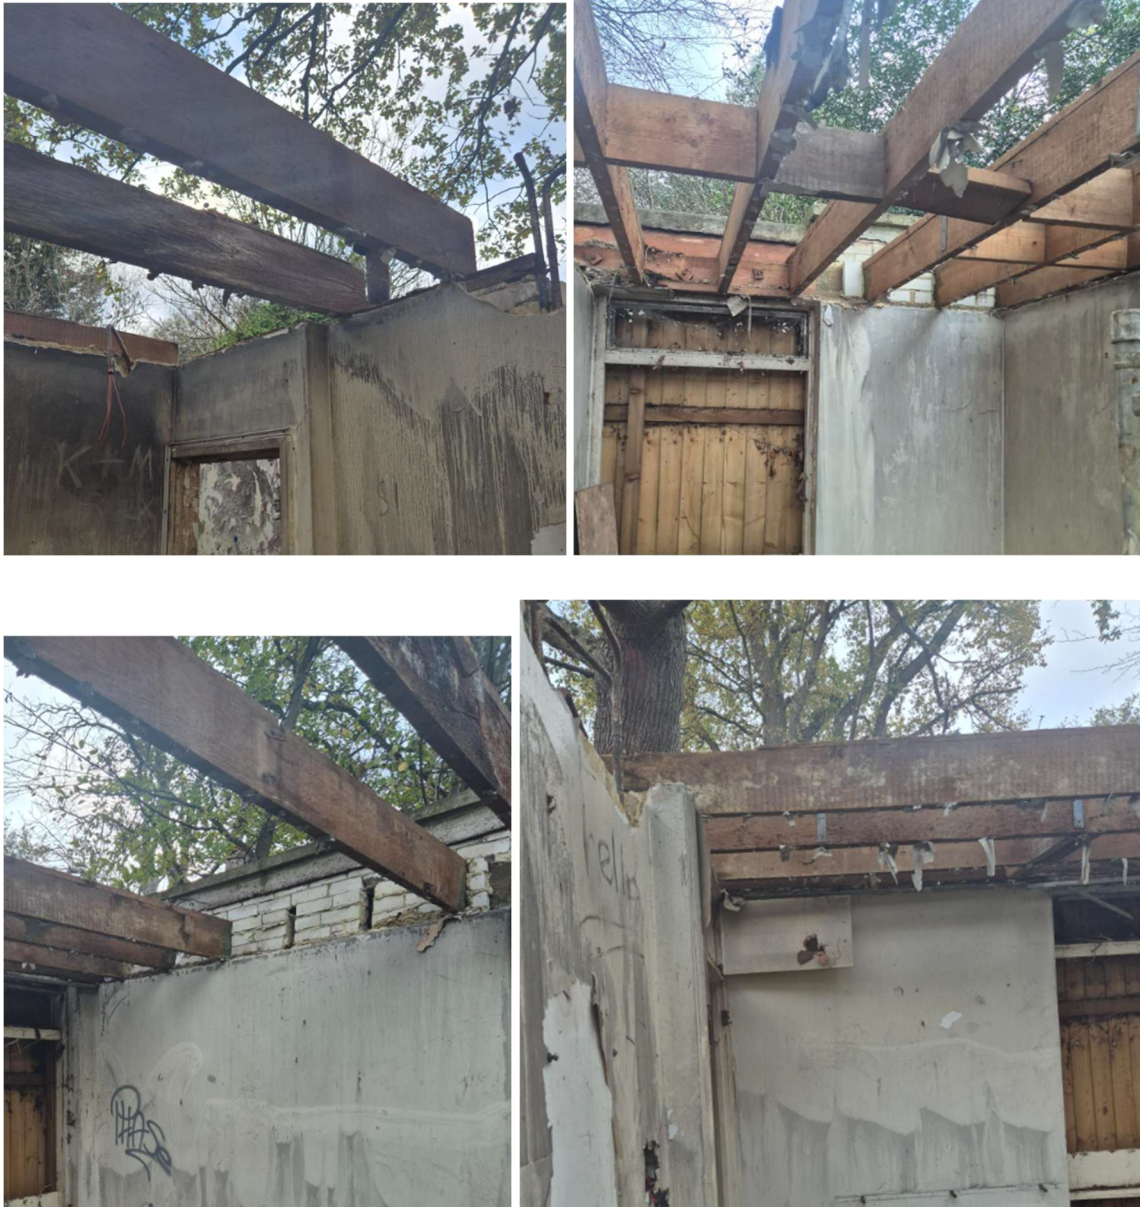
The existing roof structure has been confirmed as comprising 8" × 2" joists at 400 mm centres. Although the majority of the roof has now been removed, several sections remain in place and were inspected. The joists span between the external walls and the internal loadbearing walls, as illustrated in the markup below. The joists are overlapped and supported on the internal walls while at the external cavity walls they are pocketed into the masonry.

To eliminate combining new and old timbers, it is also recommended that the installation of the new subfloor and roof is done with new timbers members throughout.

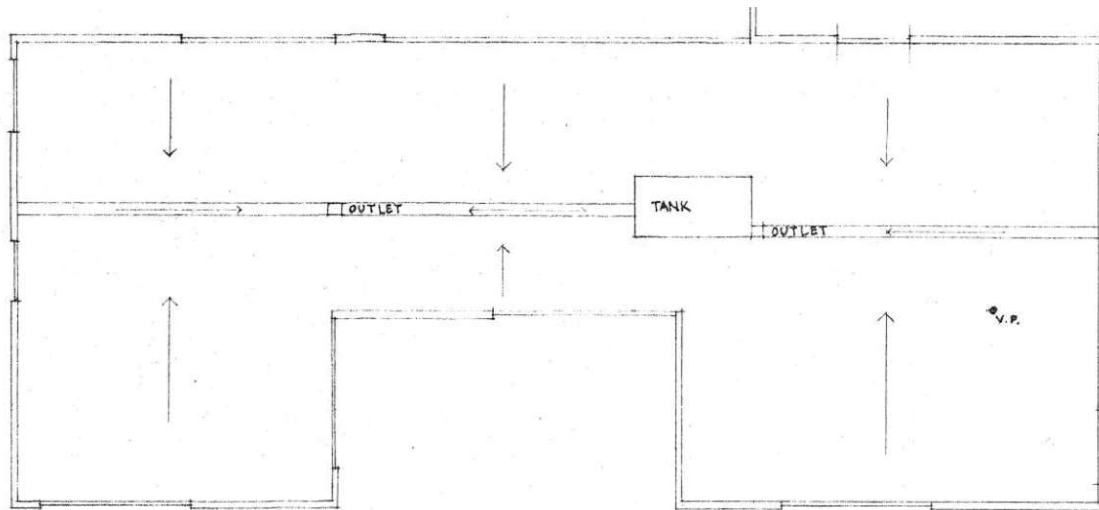
ROOF PLAN

Roof Fall
