Penge and Inkster Houses  
Wandsworth

Existing Structure Appraisal

Job number: 2160102  
Revision: P2  
Status: Preliminary  
Date: 15/12/16  
Report No: 2160102-REP-003

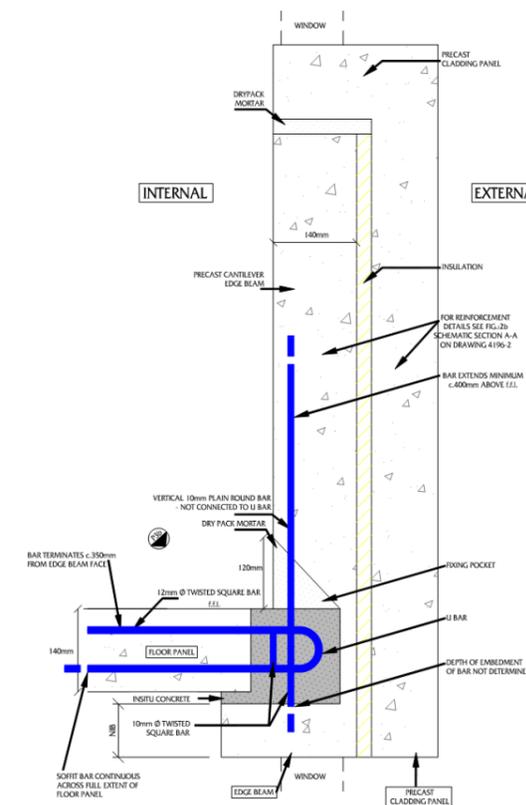
3.6 At the corners of the building, the edge beam cantilevers in order to support the floor panels. In these locations, 3 no. pockets have been formed in the edge beam, and U bars cast into the floor panels. These connections have been grouted on site. At all other locations along the elevations, the edge beam panels appear to be tied neither to the floor panels, nor to each other.

Fig 3.1: connection of floor panel to cantilever edge beam (from GBG report)

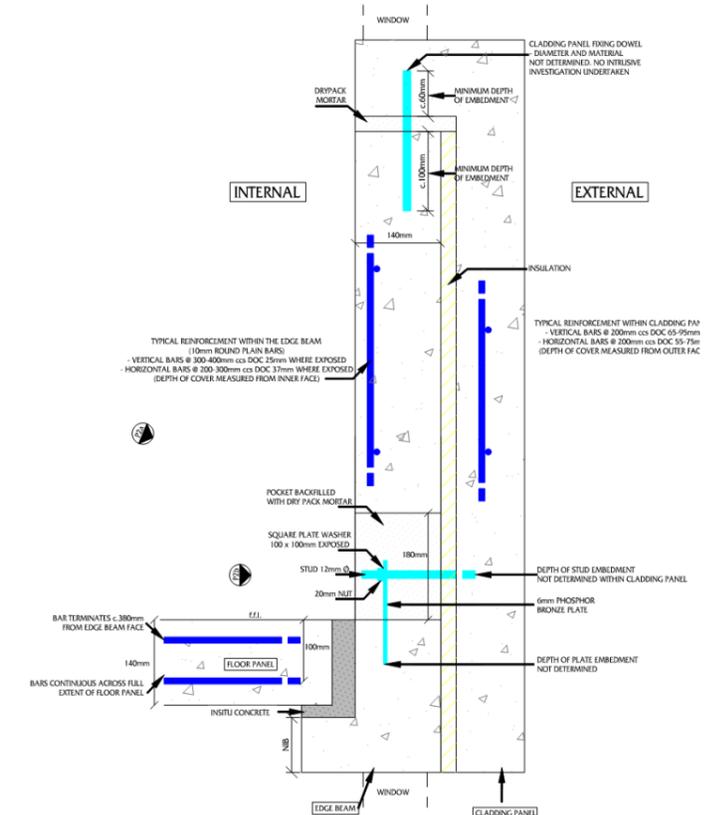
depth of the tie bars was not always found from the investigations. It is therefore difficult to assess the adequacy of these connections. The facade panels have been fixed back to the edge beams using cladding sockets and dowel bars – these details were not investigated.

Fig 3.2: connection of façade panel to edge beam (from GBG report)

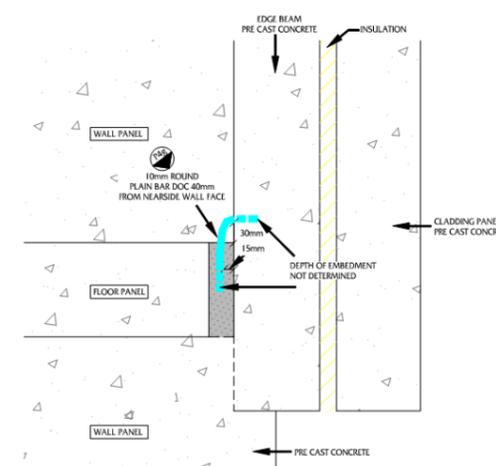
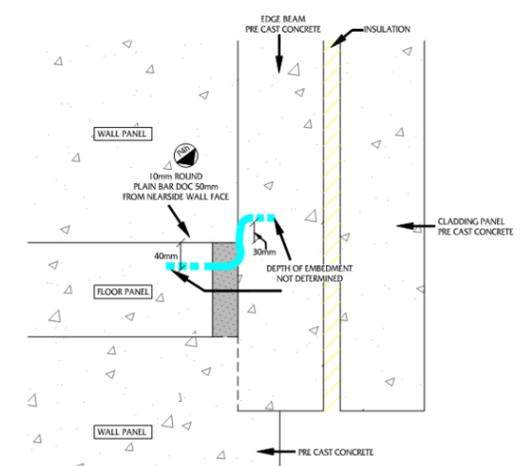
3.7 At the supporting wall locations, the edge beams have been connected to the walls with tie-back angles and grouted in tie bars. These tie bar details seem to vary considerably from wall to wall and the embedment

Fig 3.3: connection details of edge beams to wall supports (from GBG report)

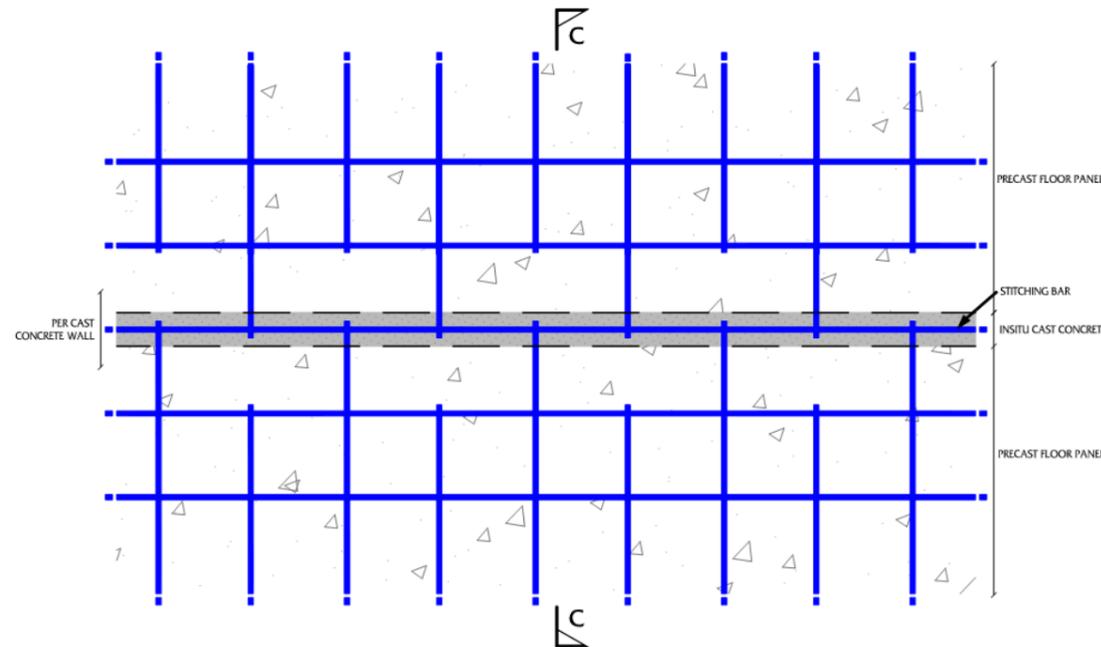
3.8 Connections between adjacent floor panels were found to have been generally formed by staggered u-bars projecting from the precast panels with a lacer bar running through the centre of them. This joint was then grouted up on site. This detail is constant with the archived drawings and seems to occur in most locations where floor panels span onto wall panels

Fig 3.3: plan of connection between adjacent floor panels (from GBG report)

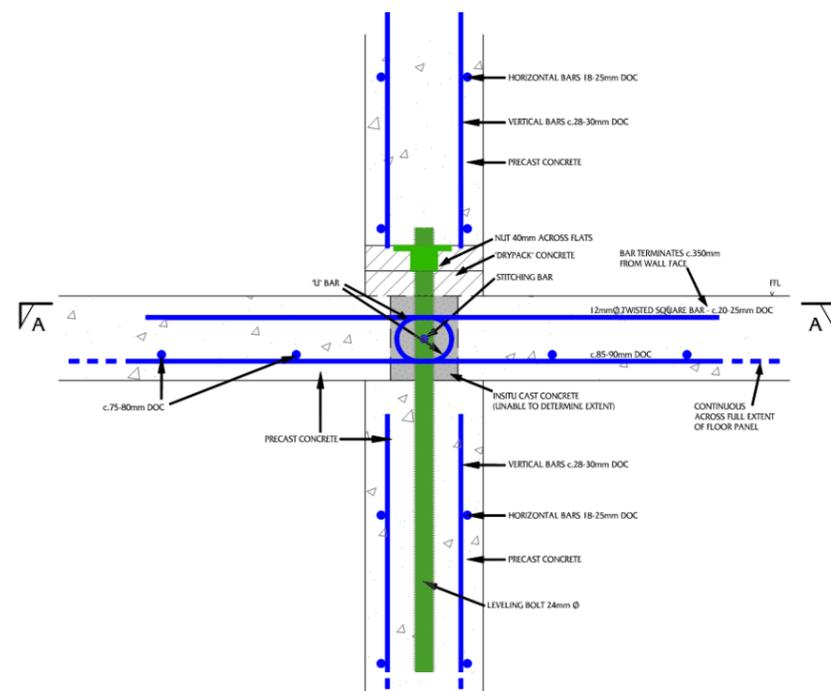
Fig 3.4: section of connection between adjacent floor panels (from GBG report)
