Arboricultural Impact Assessment

***Tooting Bec Lido, Tooting Bec Rd,
London SW16 1RU***

Project Number: P3288.1.0

Date: 31 May 2019

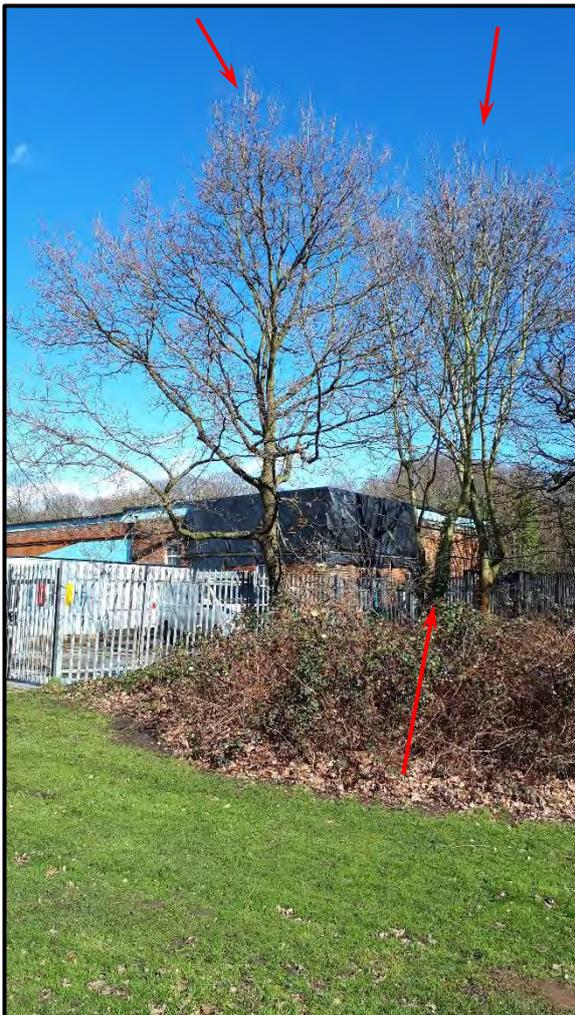
Photograph 2 (left). From left-to-right (arrowed) T1, English oak, T2 and T3, ash. Located alongside the northern fenced boundary. Viewed looking towards the north-east.

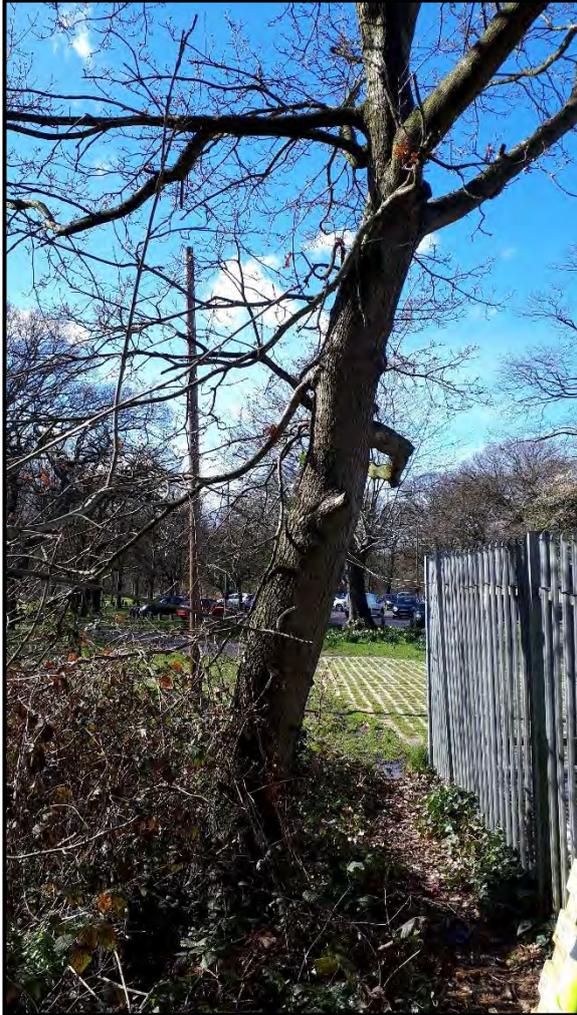
Photograph 3. Close-up of the base of T1, English oak, showing stem leaning to the north. Viewed looking towards the west.

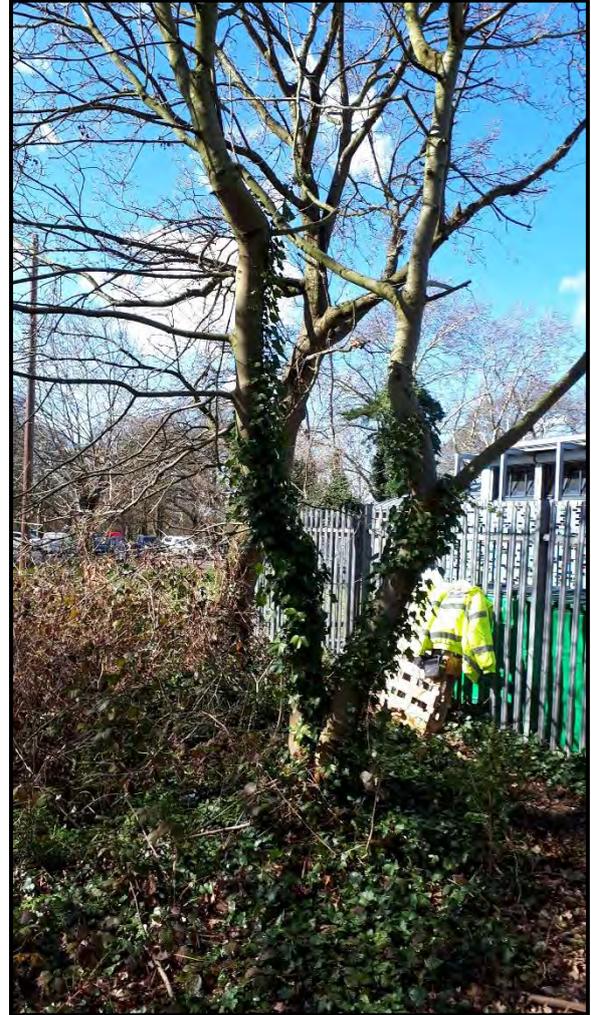
Photograph 4. Close-up of the base of T2, ash, showing, twin-stemmed form and ivy cover. T1 can just be seen in the background. Viewed looking towards the north-west.

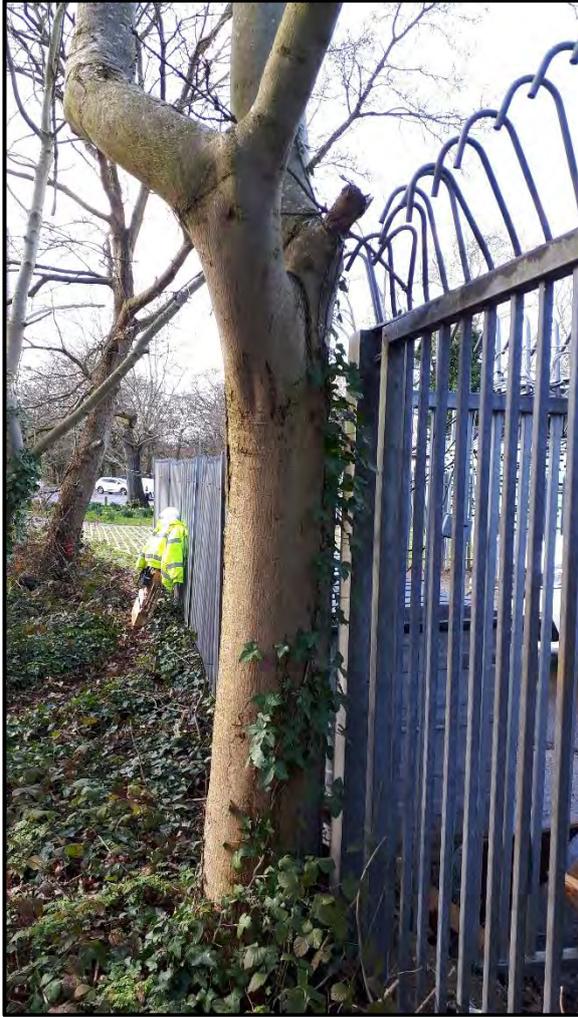
Photograph 5. T3, ash, showing location in the centre of the northern boundary and proximity to the security fence. Viewed looking towards the west.

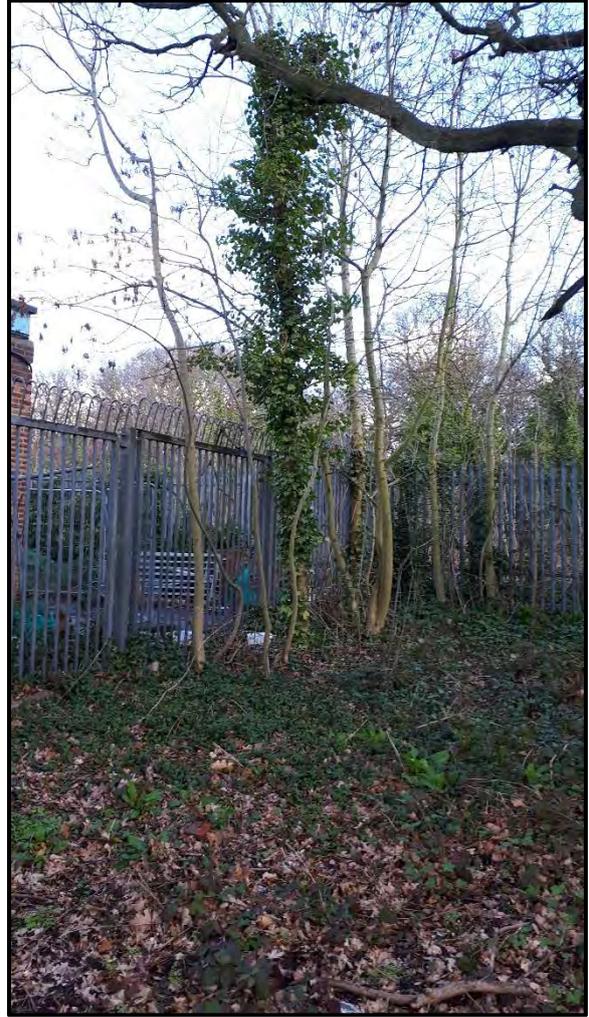
Photograph 6. G1, ash and elm, located in the north-east corner of the site. Note dense ivy cover on elm up to 6m. Viewed looking towards the north-east.

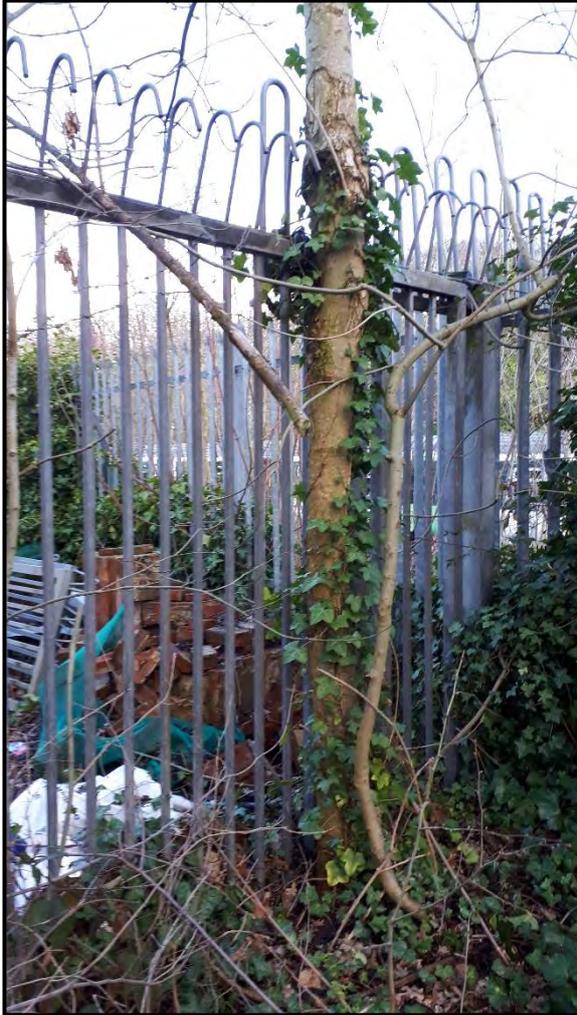
T12 was considered to be Category U and recommended for removal due to its poor condition resulting in a life expectancy of less than 10 years. One tree within G1, touching the security fence, and dead trees within G2 were also recommended for removal to prevent uncontrolled failure.

Photograph 7. Close-up of ash within G1, showing the stem touching fence at approx. 2m. Viewed looking towards the north-east.

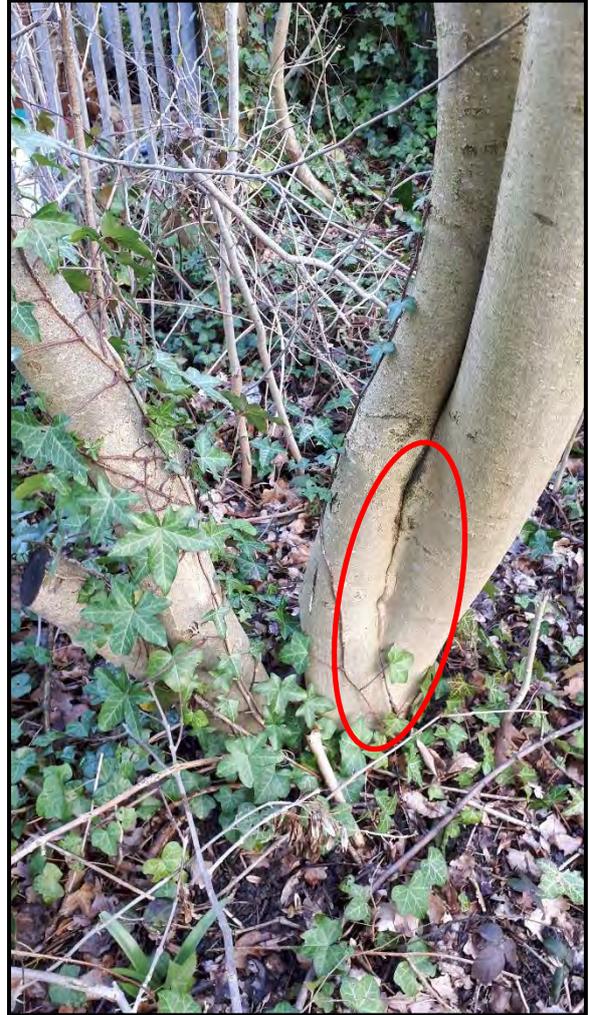
Photograph 8. Close-up of the base of the ash within G1, showing wide-mouth bark include union (circled). Viewed looking towards the east.

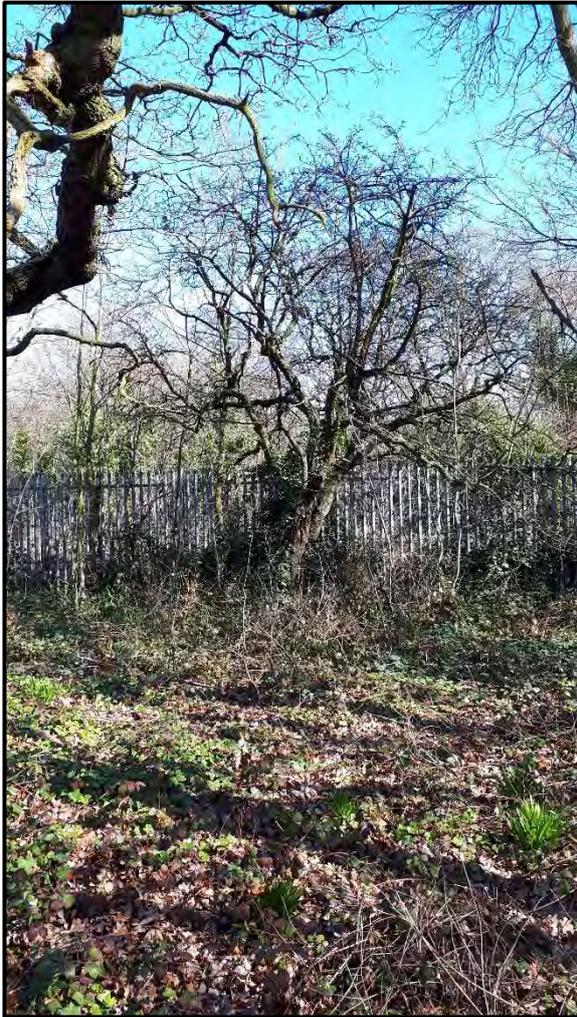
T4, was assessed as high quality, due its veteran classification and local importance.

Photograph 9. T4, veteran hawthorn, located towards the north of the boundary with the railway line. Viewed looking towards the east.

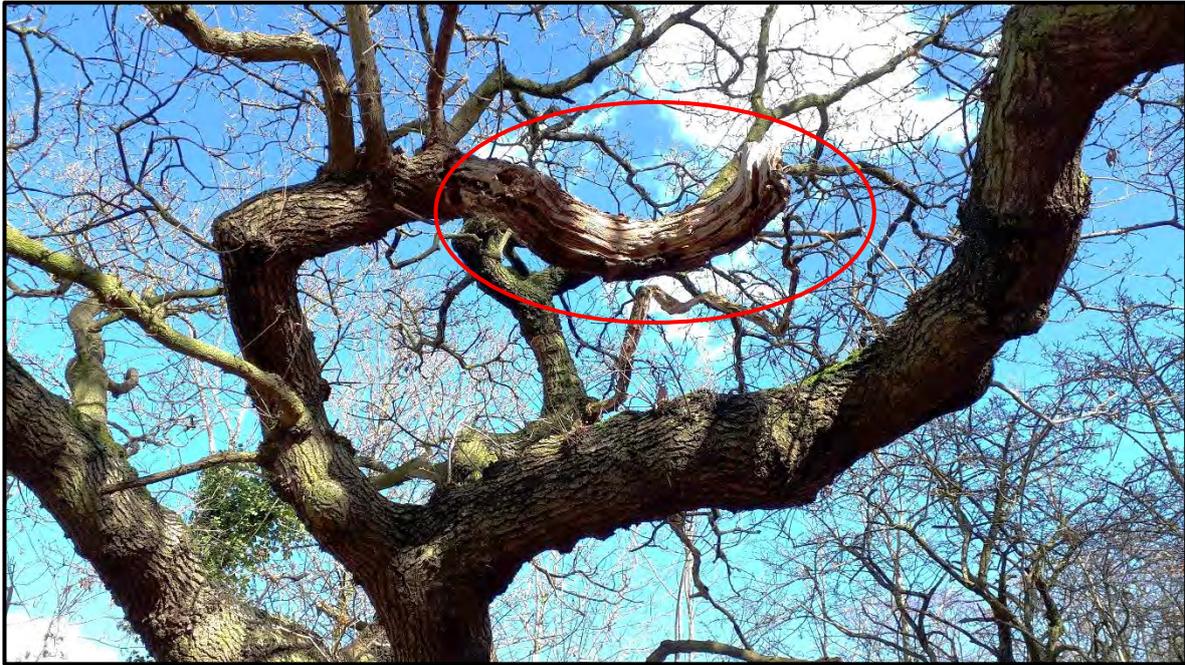
Photograph 11 (above). Close-up view of canopy of T5, showing large diameter decaying stub (circled). Viewed looking upwards towards the north-east.

T5	English oak	EM	F	12	6	6	6	6	2.0	540	Dominant tree of good extension growth. Forms two stems @ 3m with obtuse angled NFU. Extensive area of burring 400mm in diameter around branch union to the south-east. Major (>100mm diameter) decaying deadwood up to 5m in length within canopy. Decaying deadwood, 250mm diameter, 1.5m in length @ 4m to the west.	Y	No work recommended.	B1	20-40	6.48
T6	English oak	EM	G	14	6	5	3	5	1.5	440 @ 1m	Dominant tree of good extension growth and crown density. Forms two stems 1.5m with NFU. Moderate and major deadwood branches @ 1.8 and 2.1m to the south-west up to 5m in length. Moderate deadwood @ 3m to the north-west.	N	No work recommended.	B1	20-40	5.28
T7	English oak	EM	G	12	4	4	3	6	1.5	420 @ 1.2m	Intermediate tree of good extension growth and crown density. Forms two stems at 1.7m with normally formed union. Moderate deadwood, 1.5m in length @ 3m to the south-west.	N	No work recommended.	B1	40+	5.04

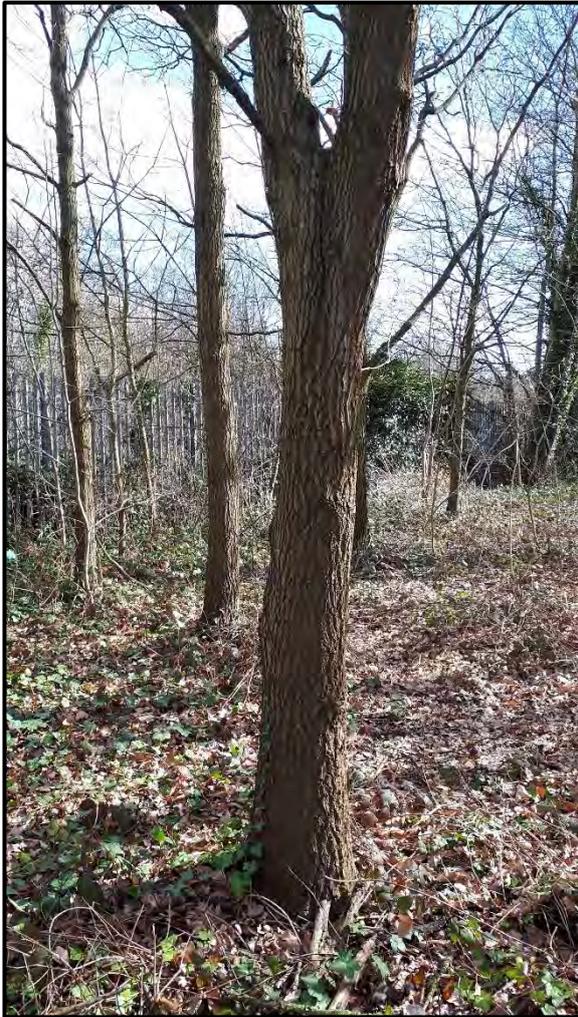
Photograph 15. T9, English oak, showing V-shaped union with bark inclusion and absence of bulging. Viewed looking towards the south.

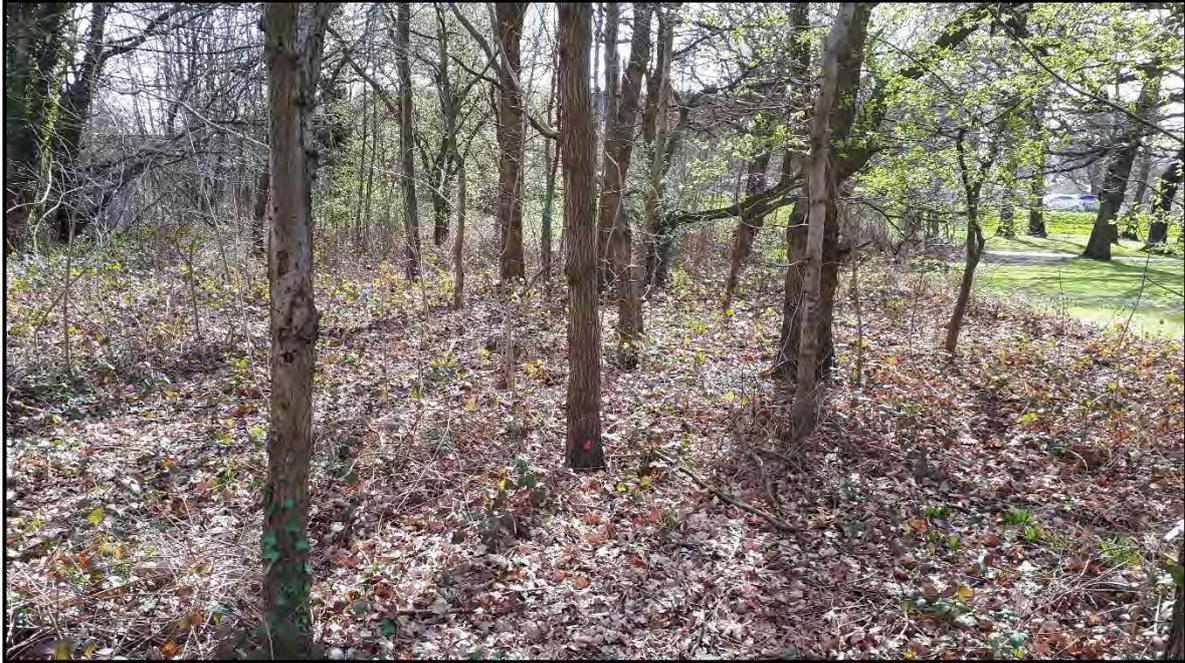
Photograph 17 (above). G2, elm and sycamore, showing typical form of understorey trees within group. Viewed looking towards the south.

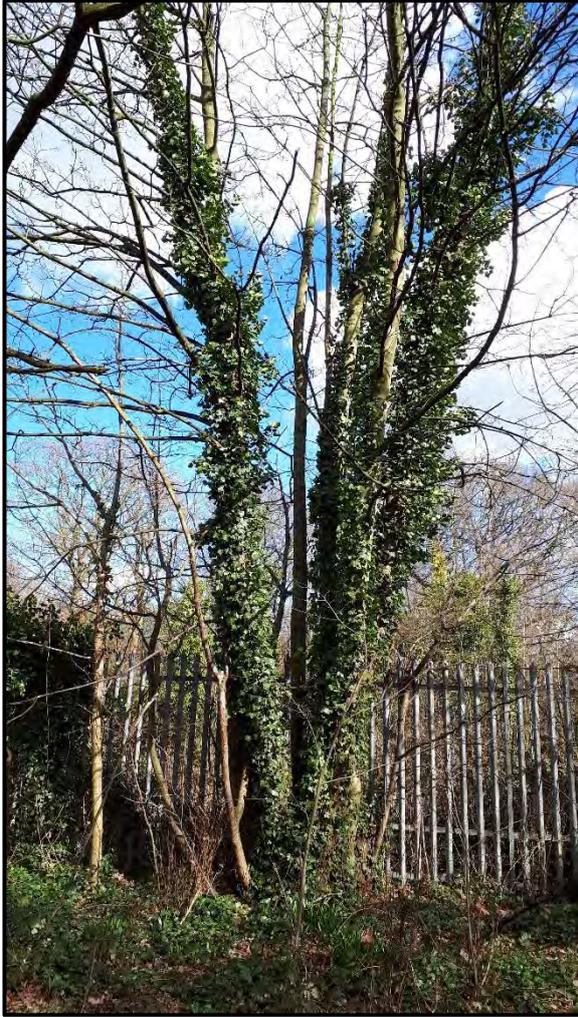
Photograph 19. T11, sycamore, showing location next to security fence, multiple stemmed form and ivy covering main stems. Viewed looking towards the east.

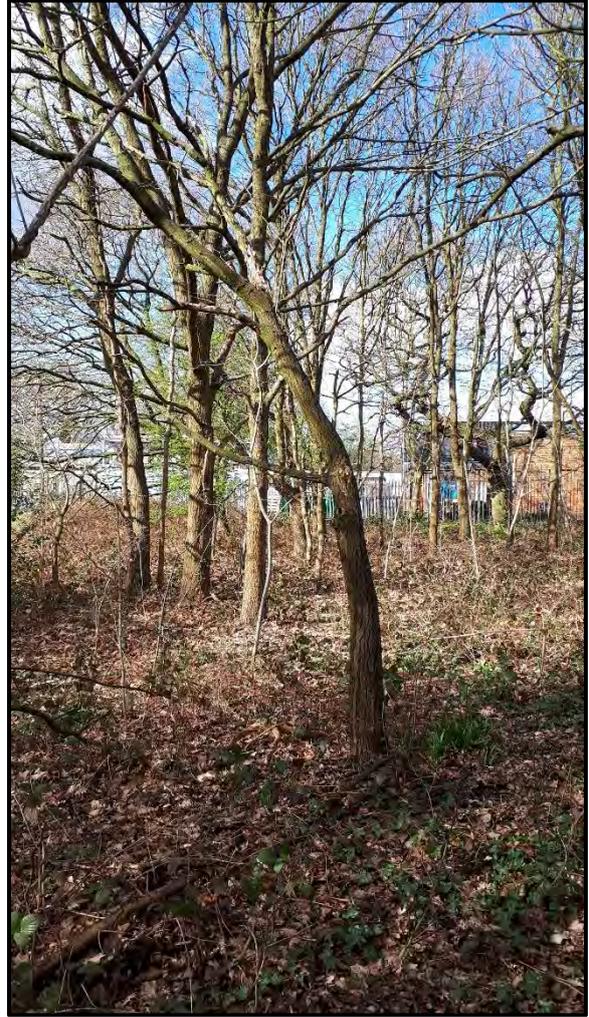
Photograph 20. T12, dead English oak, showing leaning stem. Viewed looking towards the northwest.

As removal of T12, and trees within G1 and G2, is recommended irrespective of development, any impact arising as a consequence of removal cannot be attributed to the proposal.

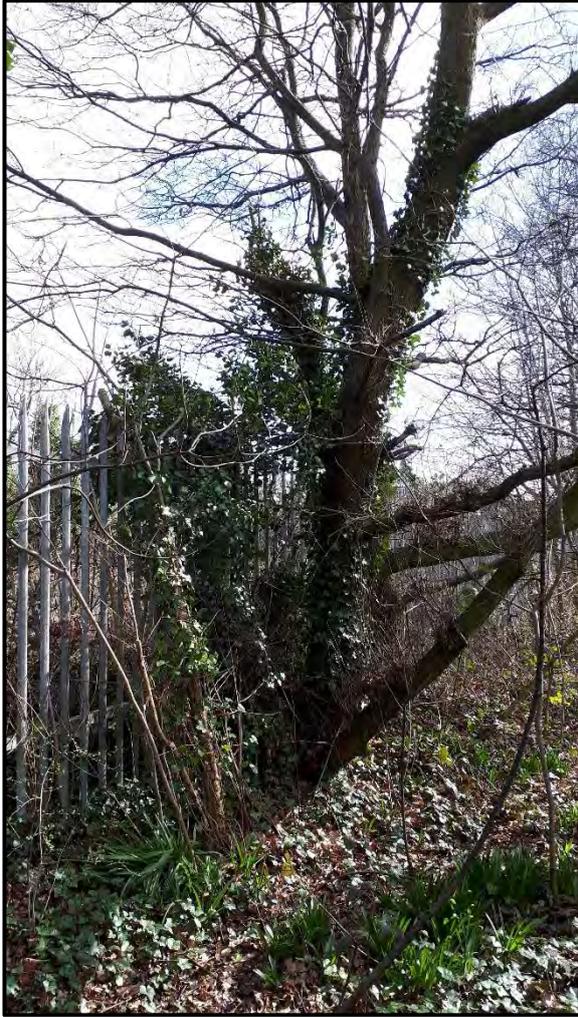
Photograph 21. T13, English oak, located just outside the red line boundary. Note dense ivy cover. Viewed looking towards the south.
