Arboricultural Impact Assessment

***Tooting Bec Lido, Tooting Bec Rd,
London SW16 1RU***

Project Number: P3288.1.0

Date: 31 May 2019

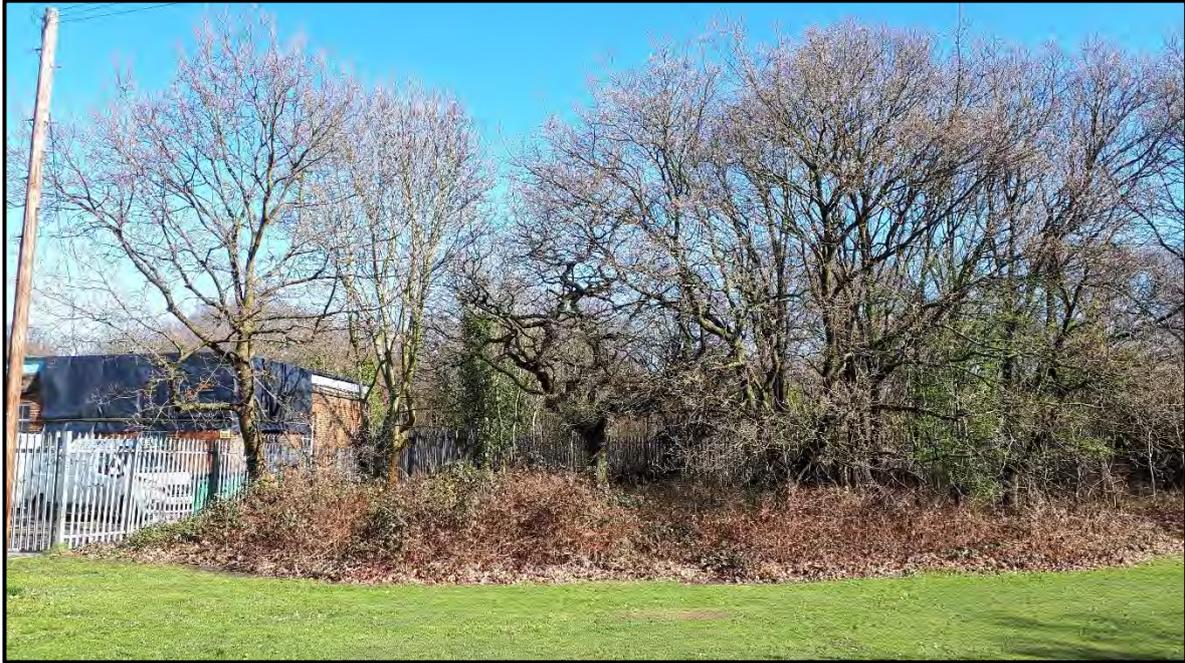
Photograph 1 (above). Overview of northern section of survey area, showing distribution and density of trees. Viewed looking towards the north-east from the adjacent open space.

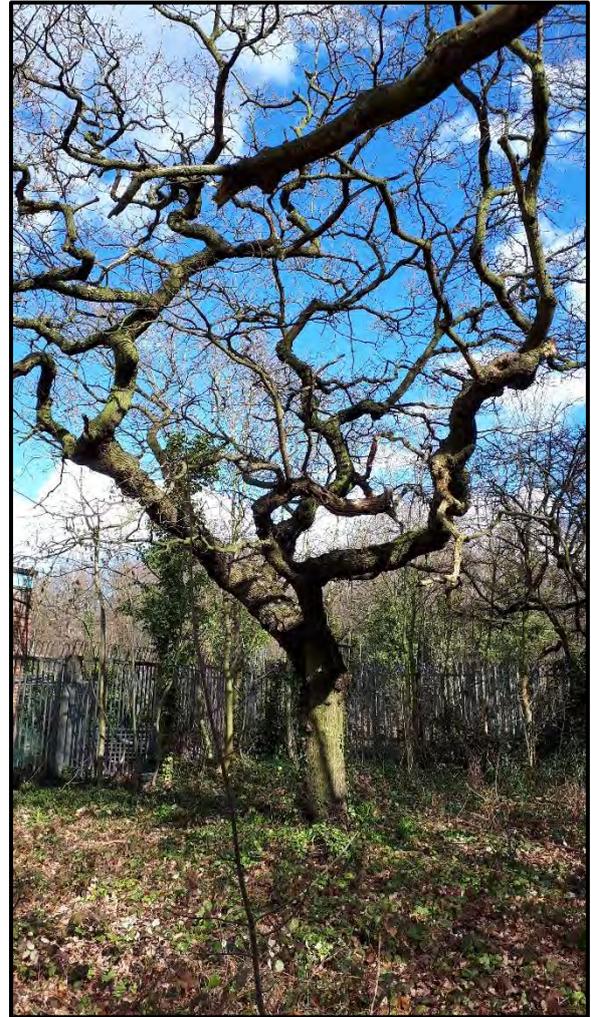
Photograph 10. T5, English oak, showing large size and high prominence. Viewed looking towards the north-east.

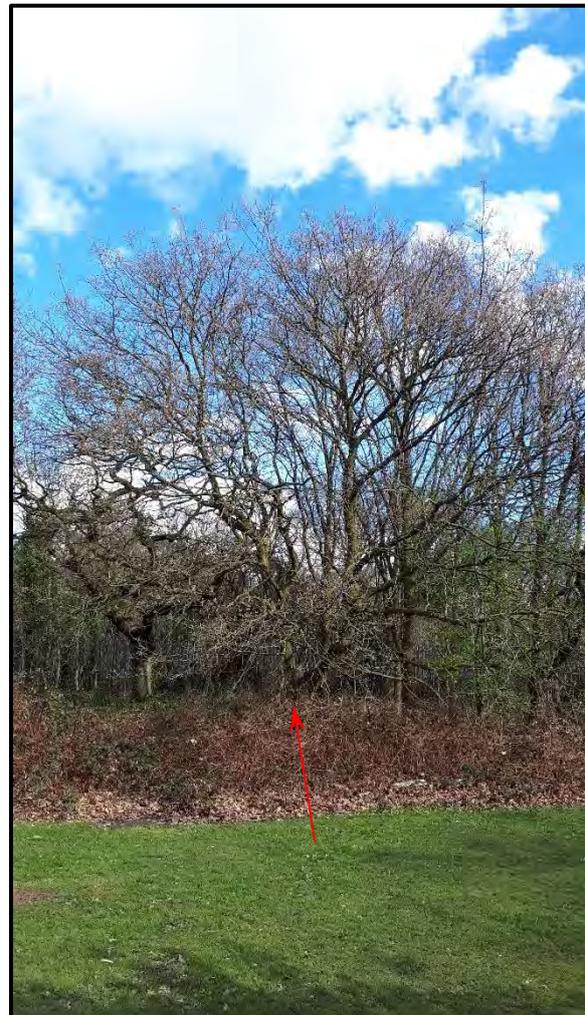
Photograph 12 (right). T6, English oak, (centre, arrowed), showing large crown size and location at the western edge of the site. Viewed looking towards the east.

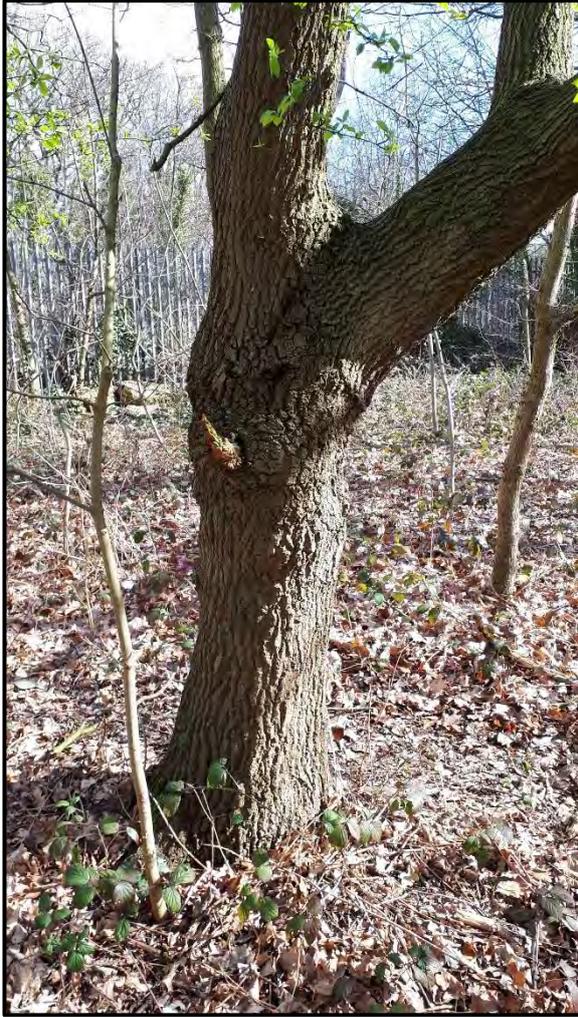
Photograph 13. T7, English oak, showing twin stem formation at 1.7m with normally formed union. Viewed looking towards the south-east.

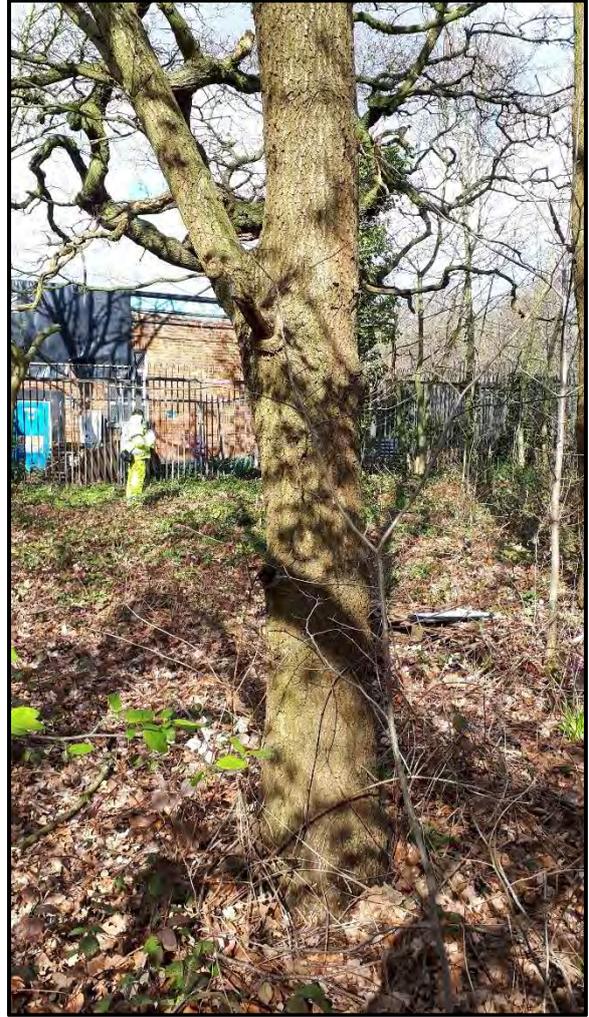
Photograph 14. T8, English oak, located centrally within the site. Note normally formed branch union. Viewed looking towards the north.

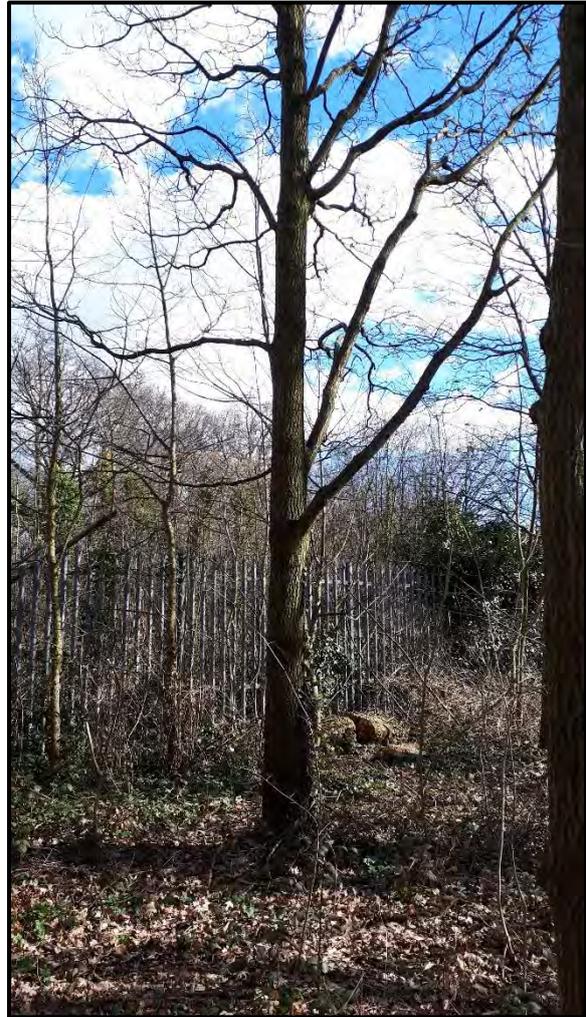
Photograph 16. T10, English oak, showing single stemmed form with good taper at base. Viewed looking towards the south-east.

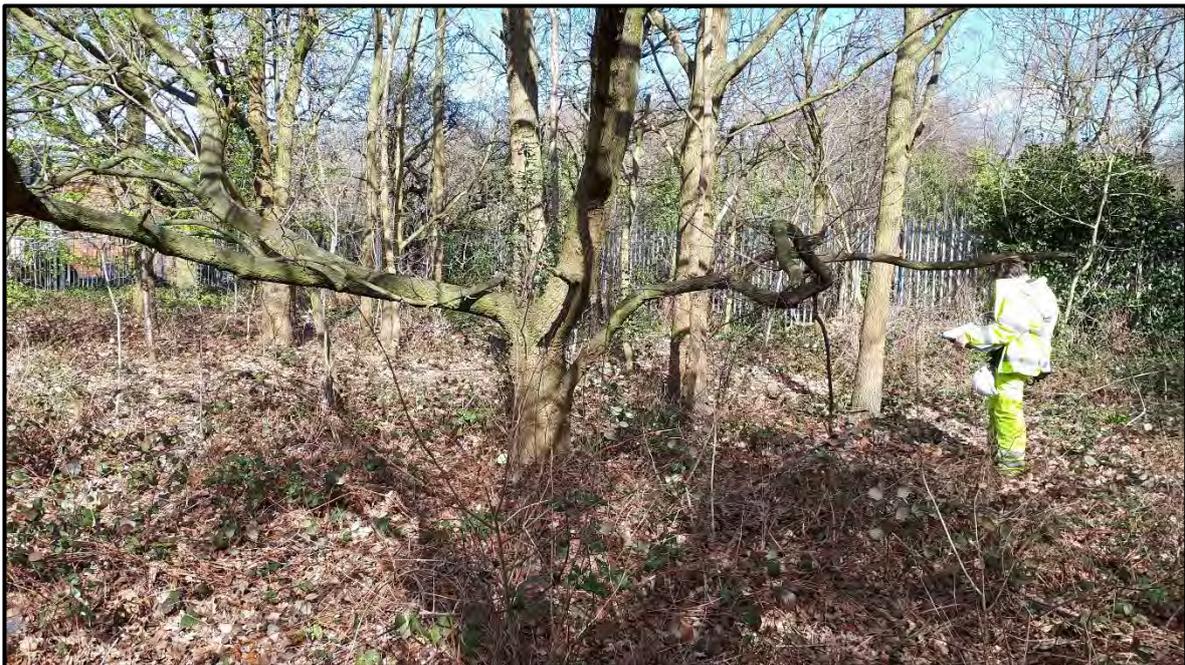
Photograph 18. G3, English oak (centre and centre-right), showing group of four larger trees with mutual crown formation, towards the south-west corner of the survey area. Viewed looking towards the north-east.
