Penge and Inkster Houses  
Wandsworth

Existing Structure Appraisal

Job number: 2160102  
Revision: P2  
Status: Preliminary  
Date: 15/12/16  
Report No: 2160102-REP-003

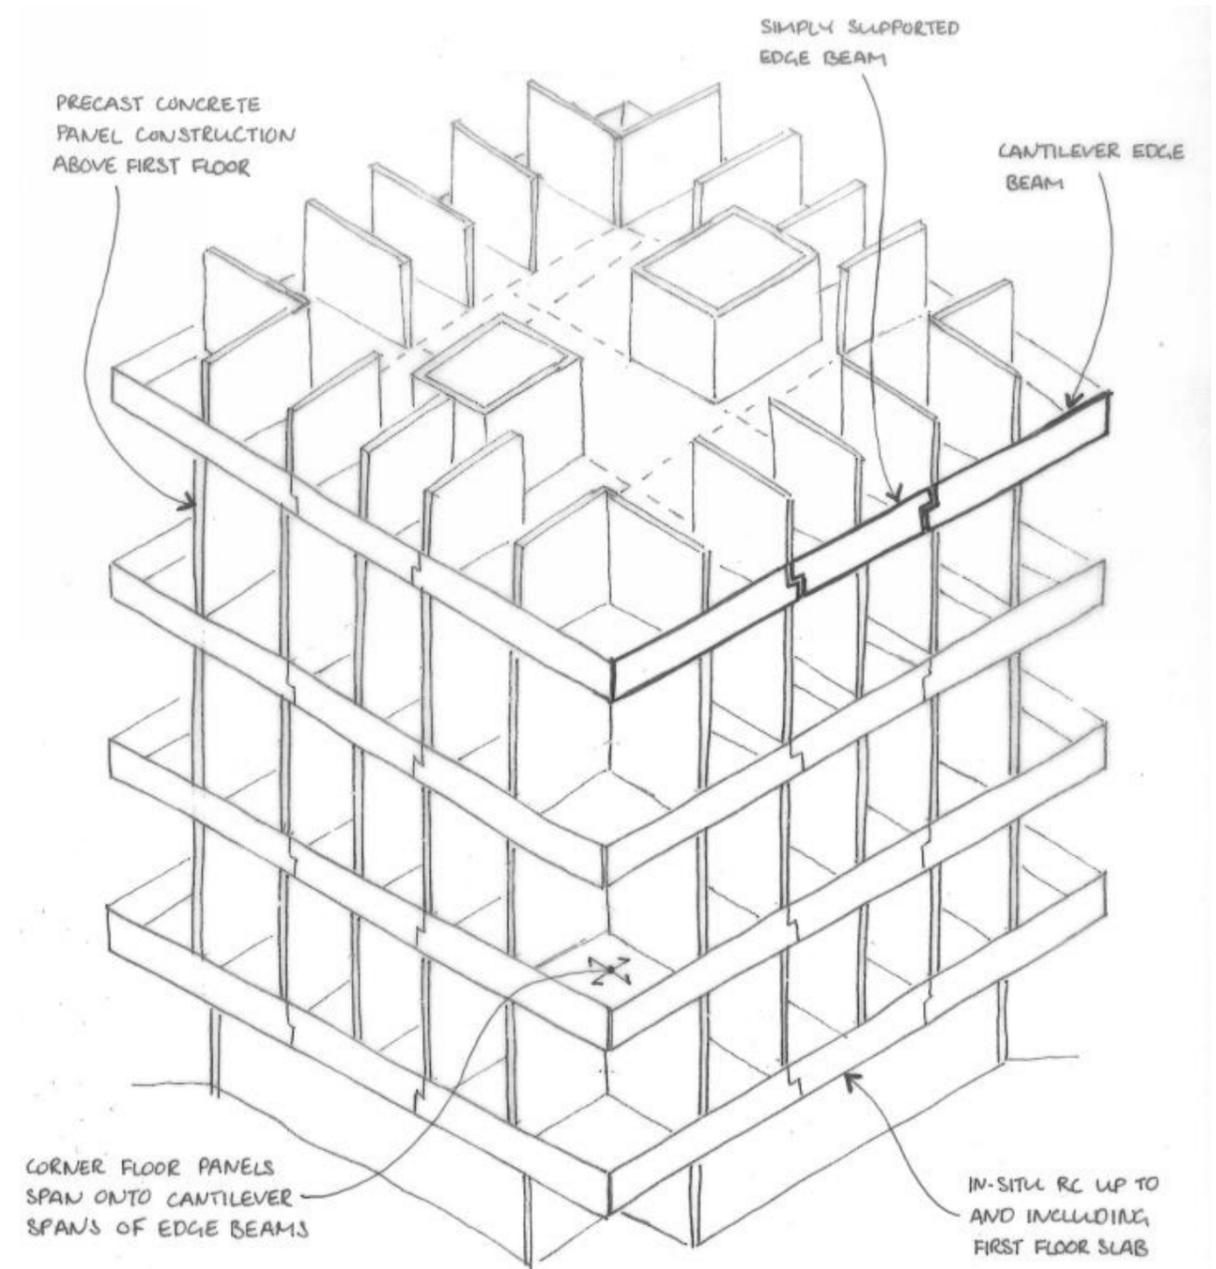
Figure 1.1: Isometric showing the existing structure of the towers

- 2.3 At first floor and above, all of the walls and floors have been formed from precast concrete panels. The panels were cast on site, before being craned into place and grouted together. The archive drawings show that the walls are typically 180mm thick and the floors 125mm thick. The floor panels span onto the wall panels at each connection, and are noted on the drawings as having 25mm bearing.

- 2.4 The lateral stability of the buildings is provided by the precast concrete wall panels which collectively act as multiple shear walls. These line up down the full height of the building and with the in-situ walls at the base to transfer both vertical and lateral loads down to the foundations.

- 2.5 The façade is formed from horizontal bands of precast concrete and bands of windows. The precast façade panels are supported on inner precast edge beams which span between the internal wall panels. At the corners of the buildings, the edge beams cantilever and support both the floor slabs and the outer cladding.

- 2.6 The archive drawings included some details of ties between adjacent floor panels, however no details of vertical ties between wall panels were found within the historic details available.
