# Tooting Bec Lido Pump House Design and Access statement

Application for Full Planning Permission

Tooting Bec Lido  
Tooting Bec Road  
SW16 1RU

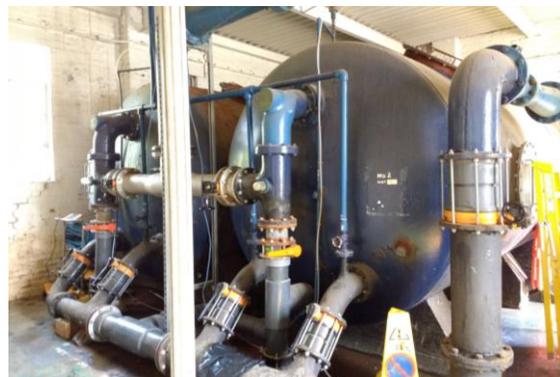
Deep end vessels in South room

The mechanical equipment is monitored regularly by the current end users – according to the latest assessment, the 2 deep end vessels located in the South room must be replaced in 2023 at the latest while the 3 cascade filters in the North room may endure 10-20 years more.

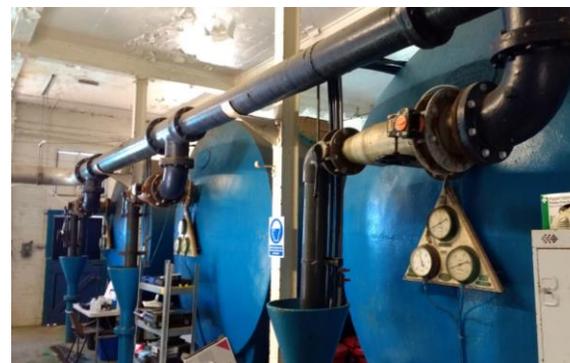
Cascade vessels in North room

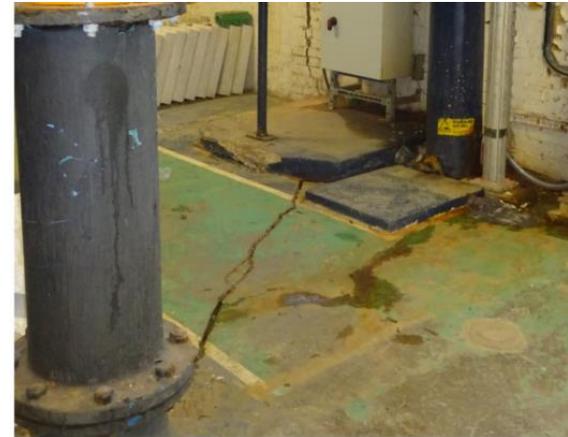
Slab crack

This structural movements are most likely due to clay shrinkage or heave, with foundations bearing on highly shrinkable clay. The cracking is now extending to the roof and the floor slab, putting the stability of the entire building at risk.

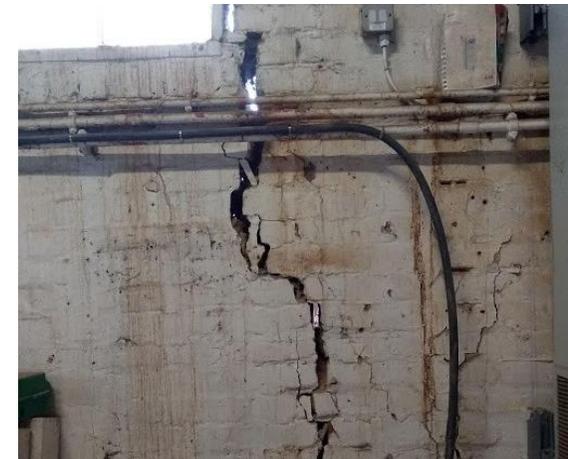
Wall crack

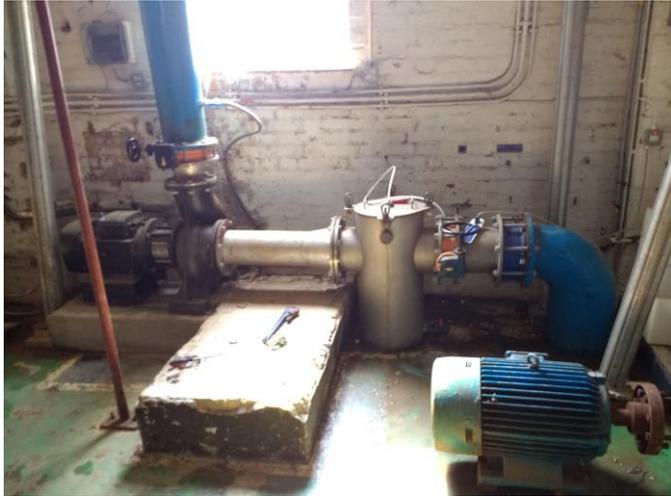
Pump

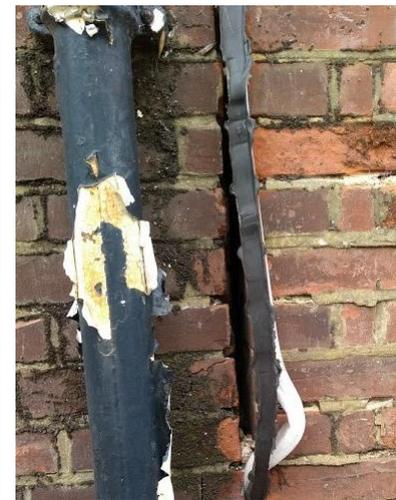
Cracking between rooms

Some underpinning works were carried out about 10 years ago as cracking and slab movements were reported. Both rooms are currently suffering from movements but the South room cracks have worsened in the last two years.

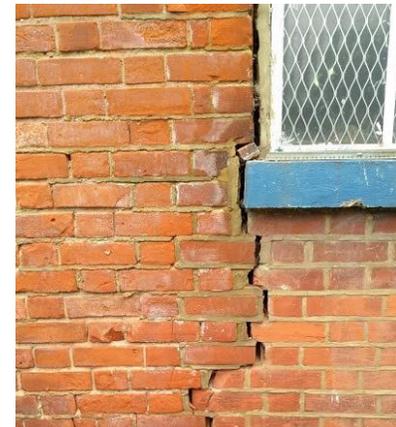
Typical wall cracking

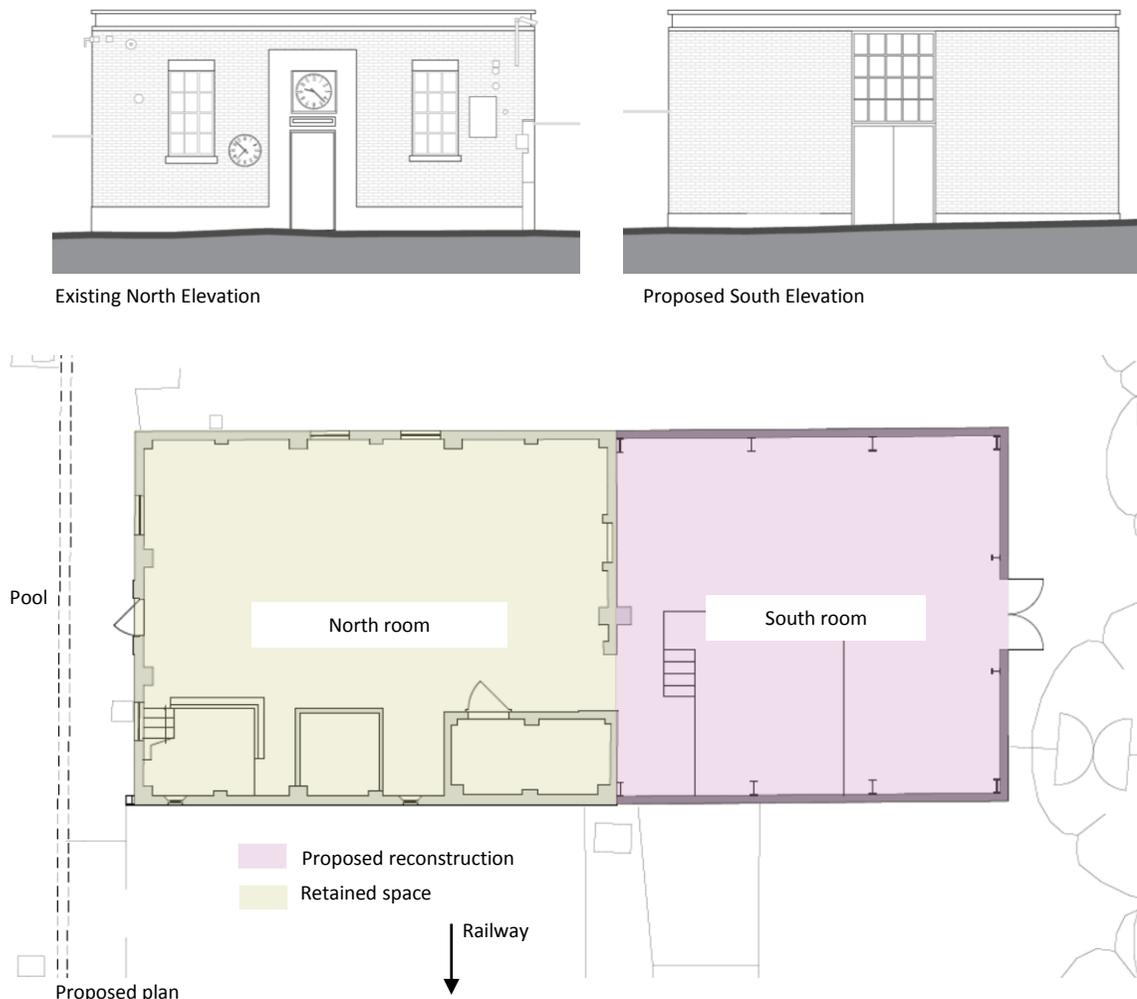
The proposal is to reconstruct the South Room with the same footprint and volume of the existing one. This way, there would be a minimal visual impact to the existing character of the area.

The design of the South elevation is symmetrical and complements the architectural language of the existing North elevation: a big window is vertically aligned with the main door located to the centre of the facade.

The new mechanical equipment would be installed adjacent to the external walls and would obscure the natural light in case windows were installed on the side elevations. Indeed, it is preferable to provide two blank walls to the East and West elevations and daylight would be allowed through roof sun pipes and the big window located above the main entrance door.

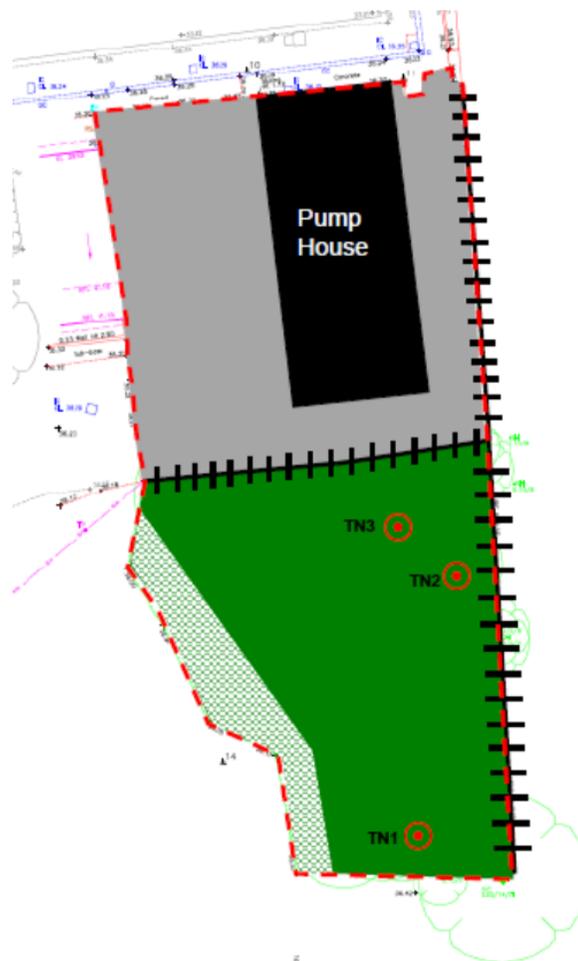
Habitat Map From Ecological impact assessment showing the hardstanding area in grey and the woodland in green

The development has a minimal impact on the natural environment: the attached Ecological Impact Assessment explains that “the site affected by development works was dominated by hardstanding and a building which were of negligible ecological importance”.

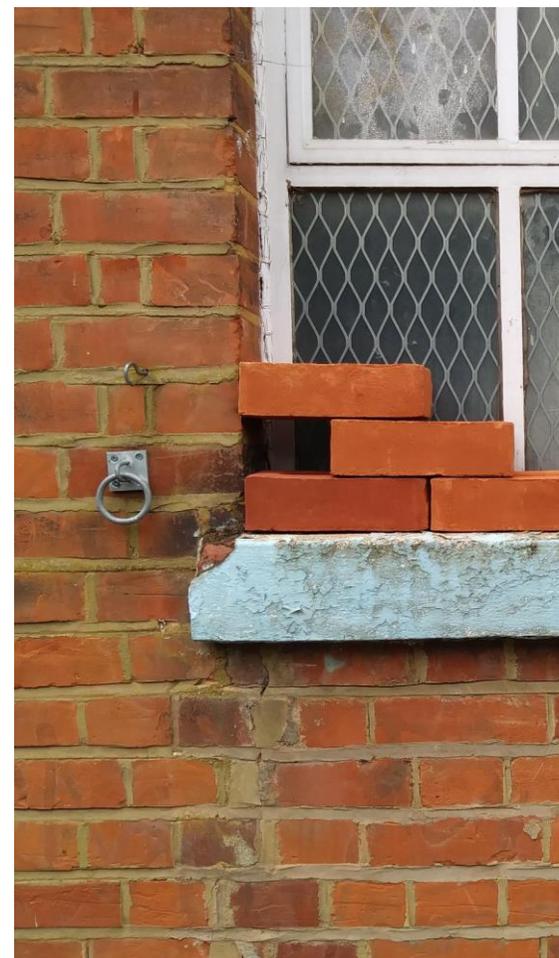
Proposed bricks in light red compared with existing bricks
